Timber structures

Case studies

PIETRO CROCE

Assessment of existing structures

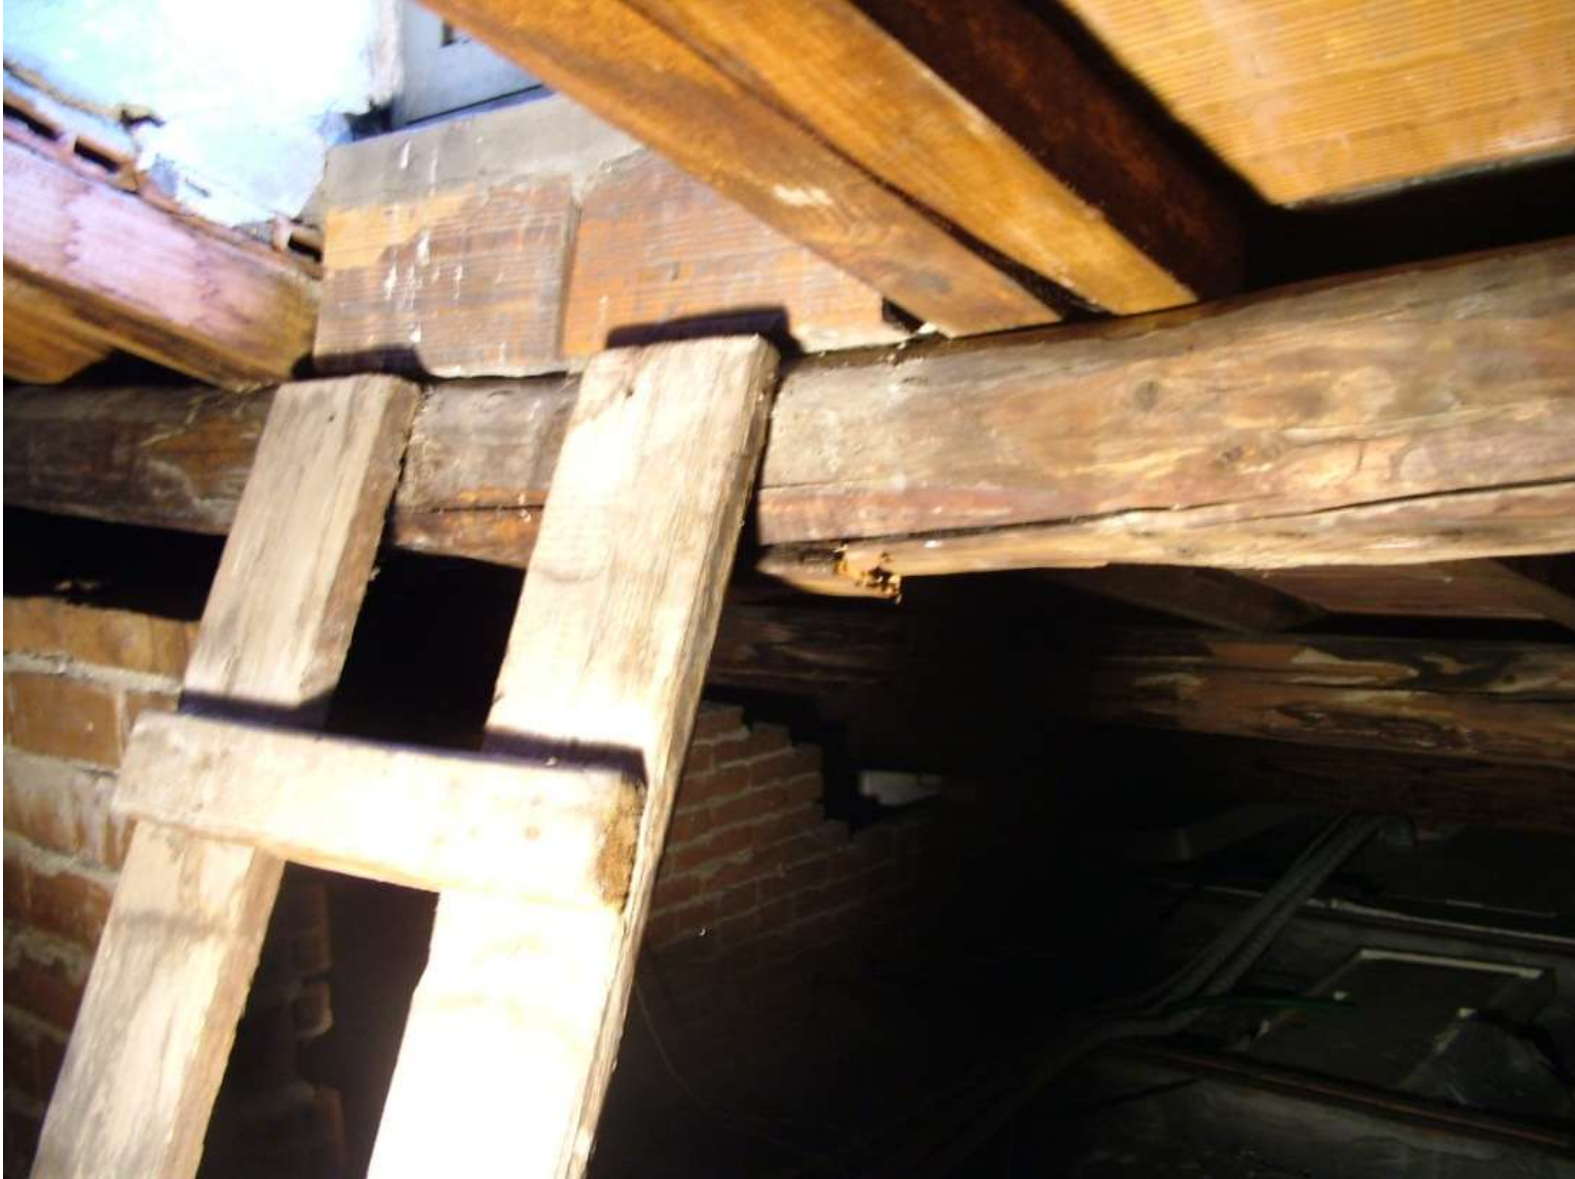
Cracked beam

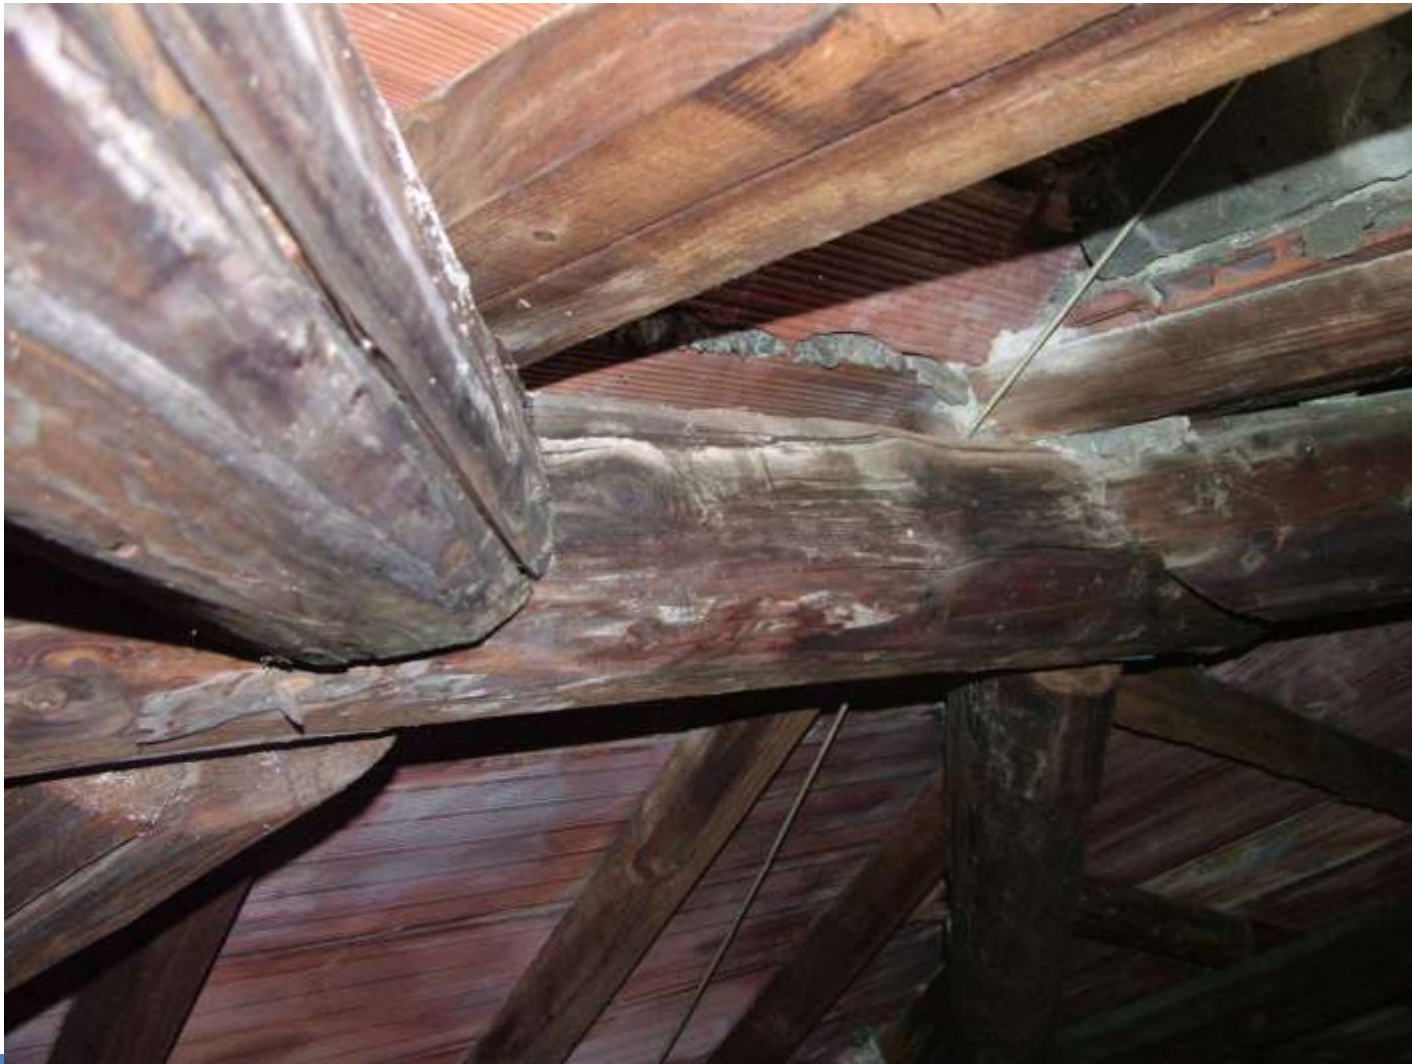
Cracked beam

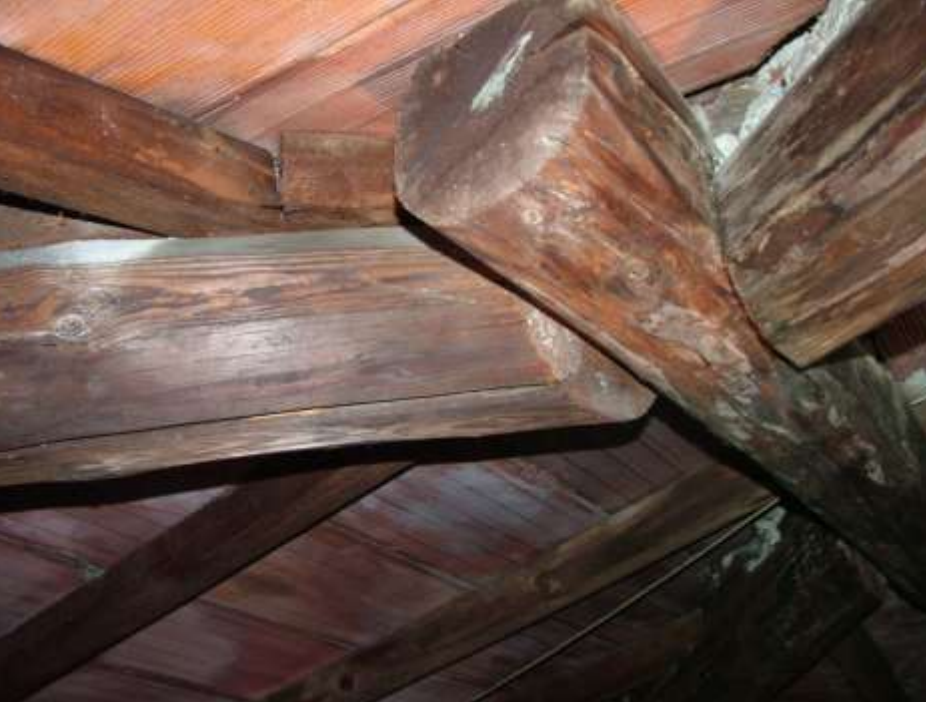
Damaged columns

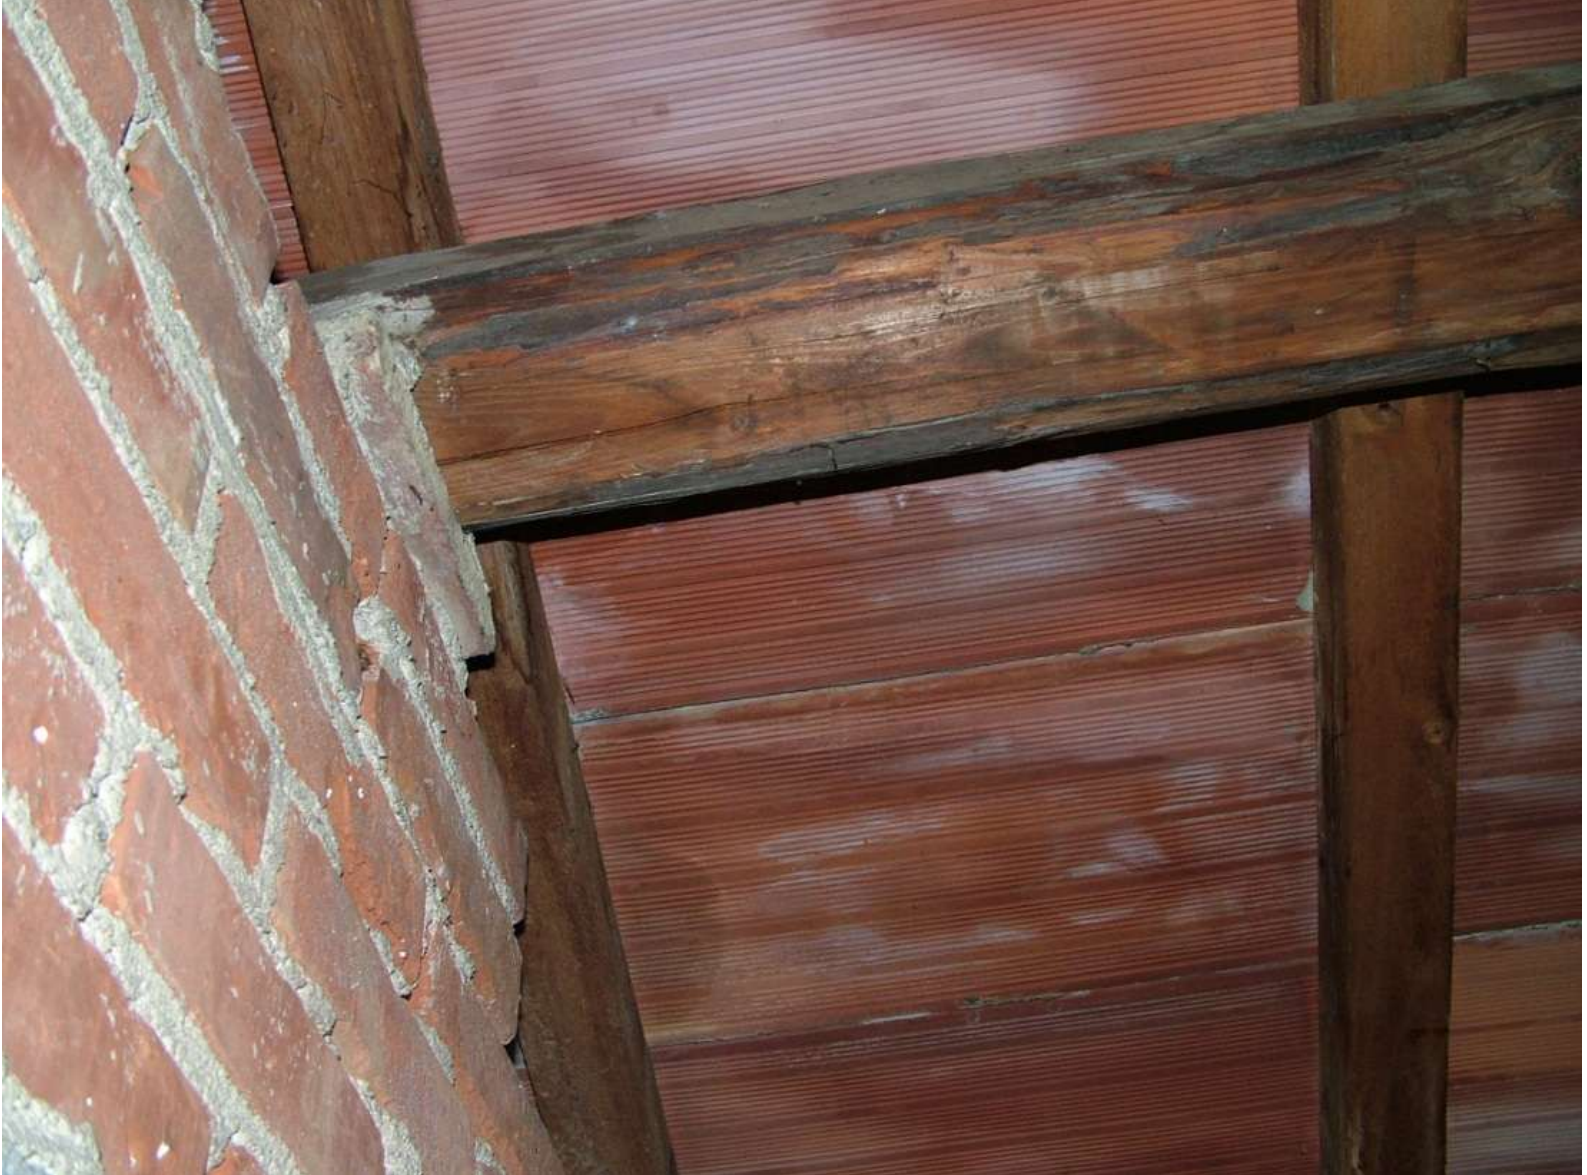
Crack pattern in a beam

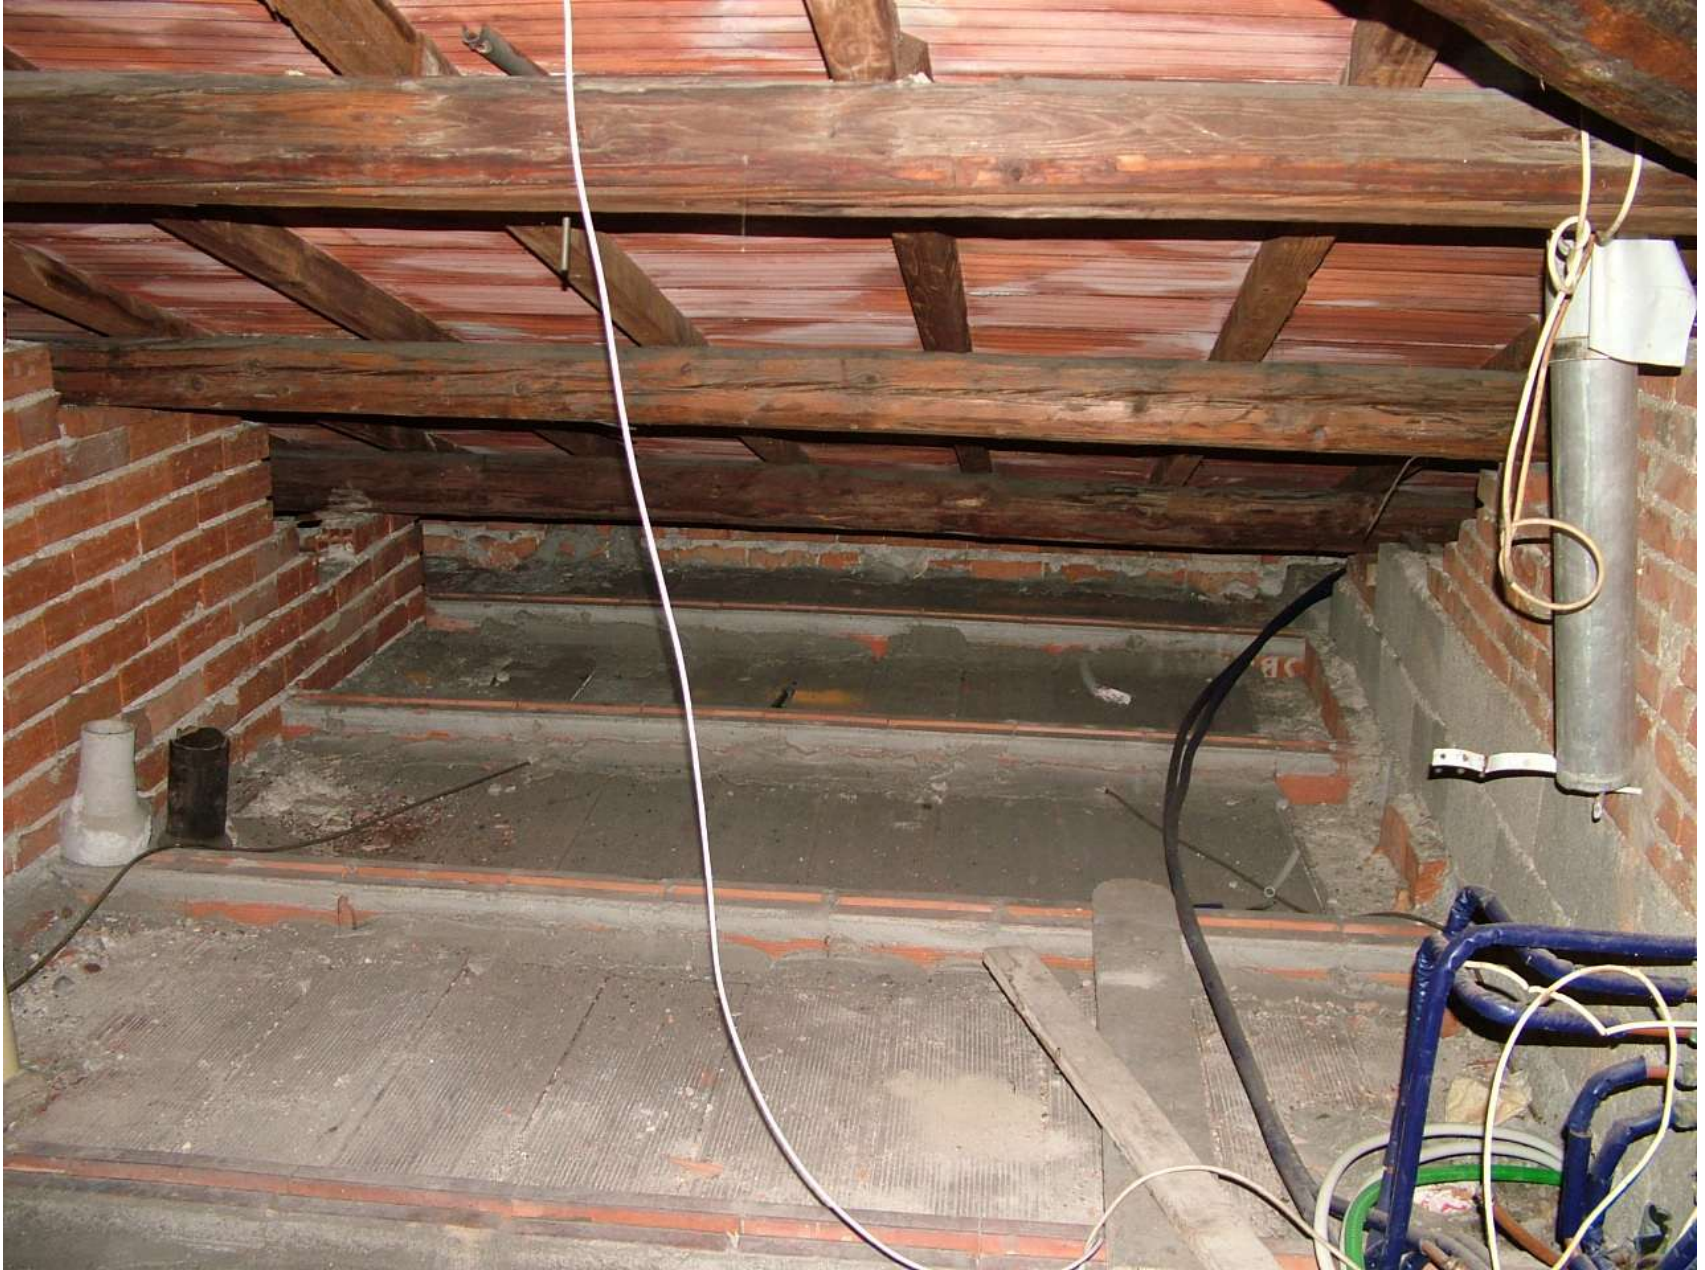
Cracked beam

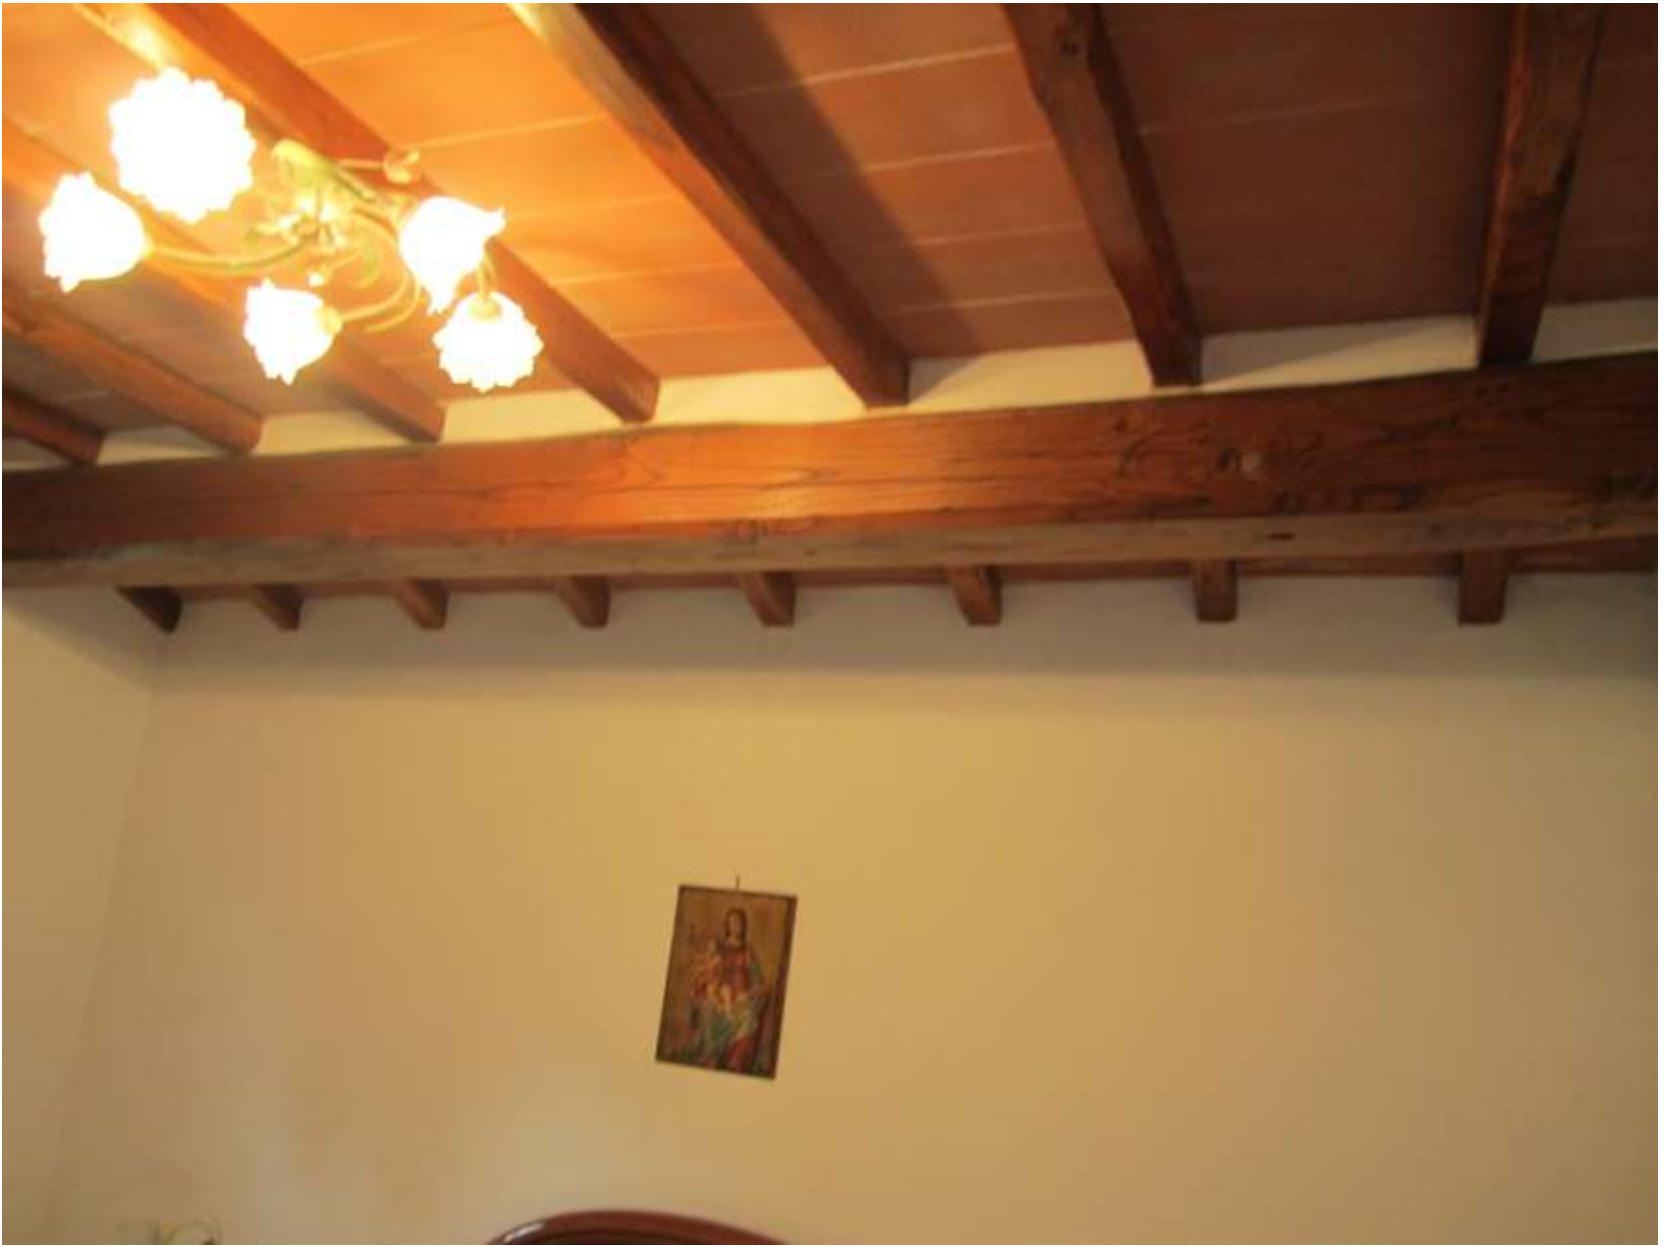
Insufficient cross section – Uncorrect wood fibre pattern

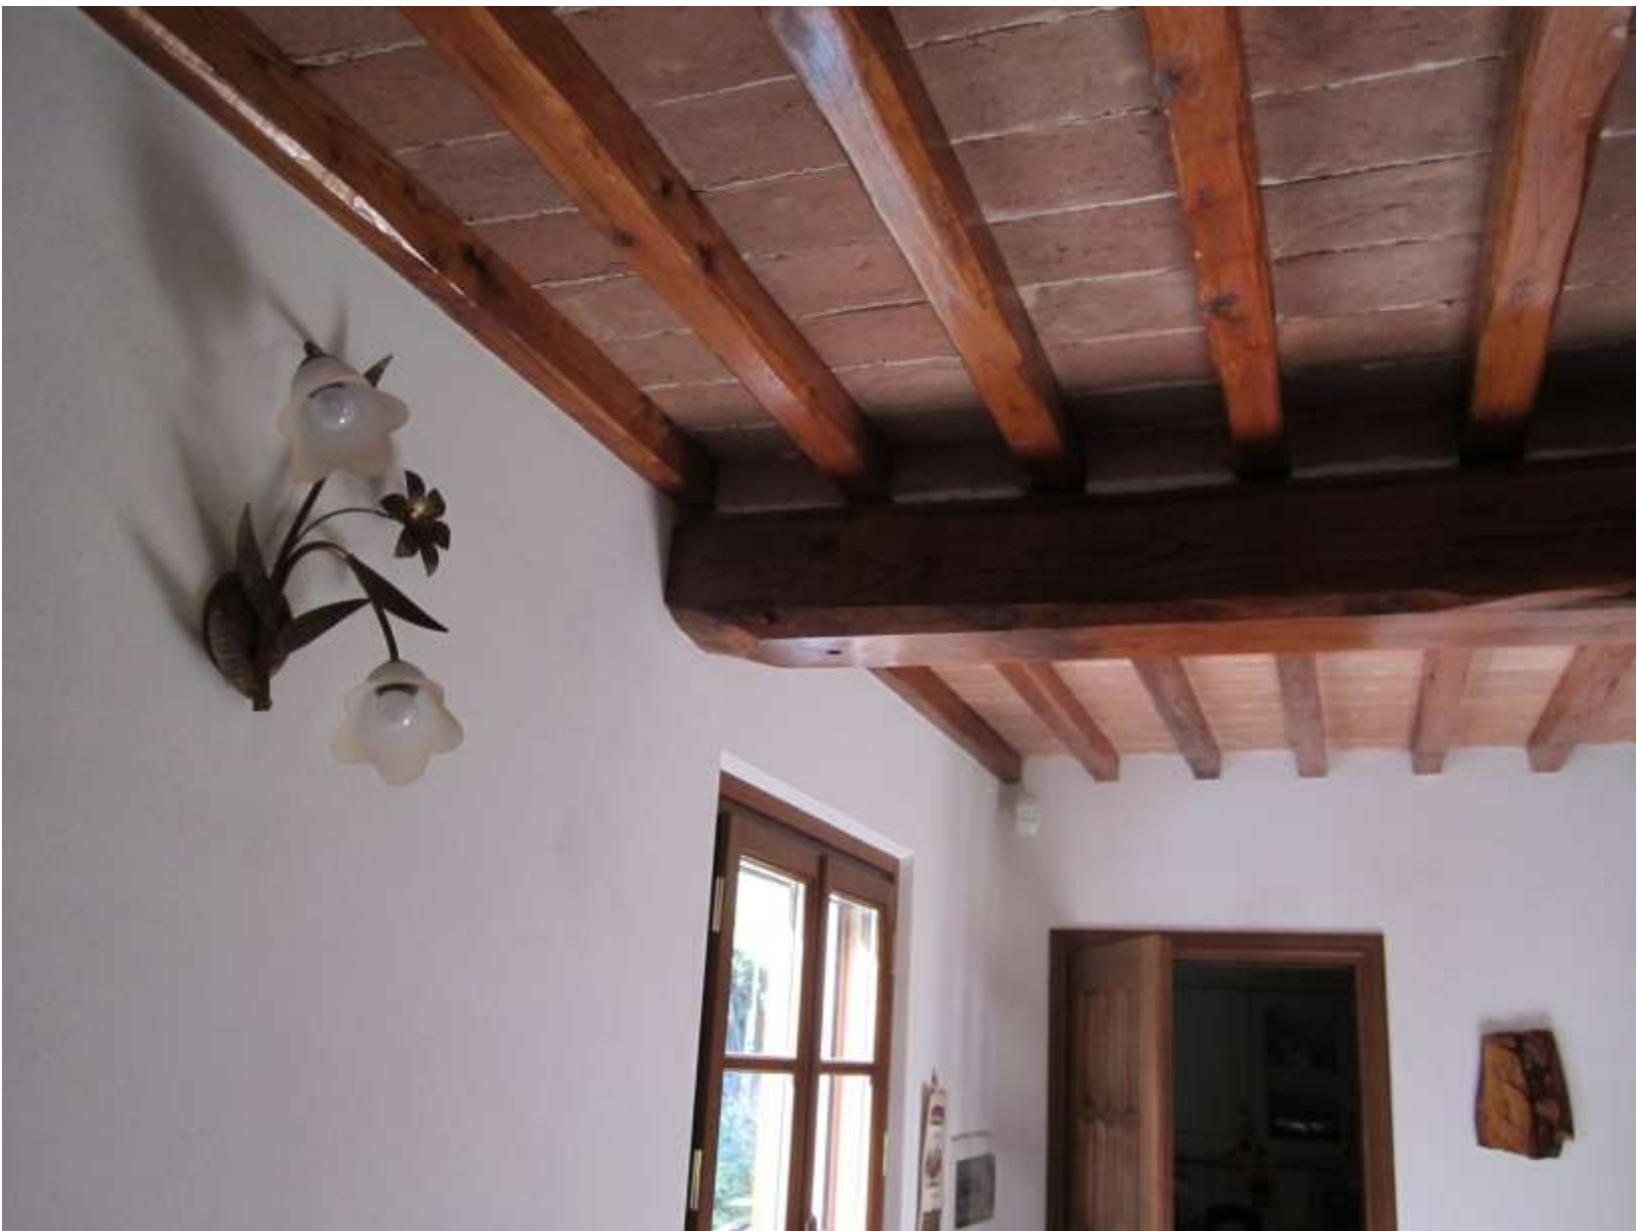
Insufficient cross section – Uncorrect wood fibre pattern

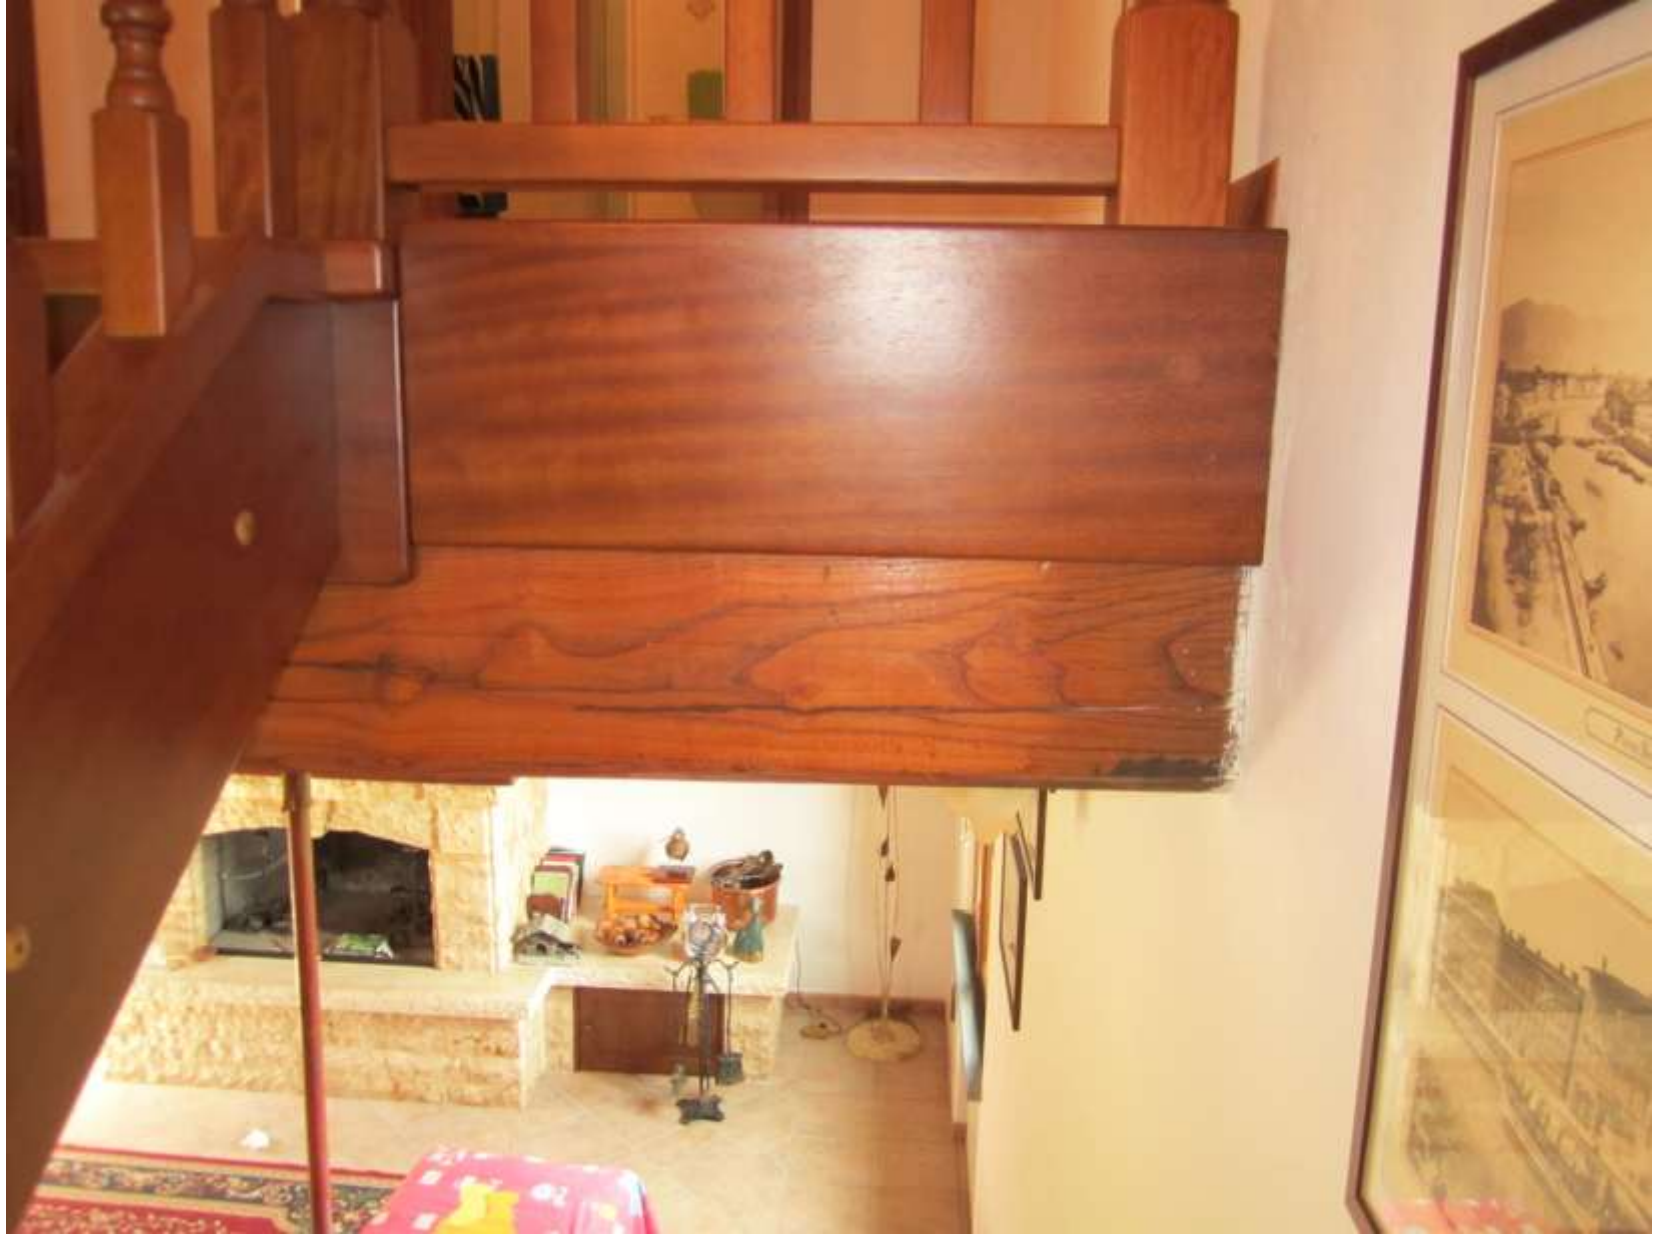
Insufficient cross section – Uncorrect wood fibre pattern

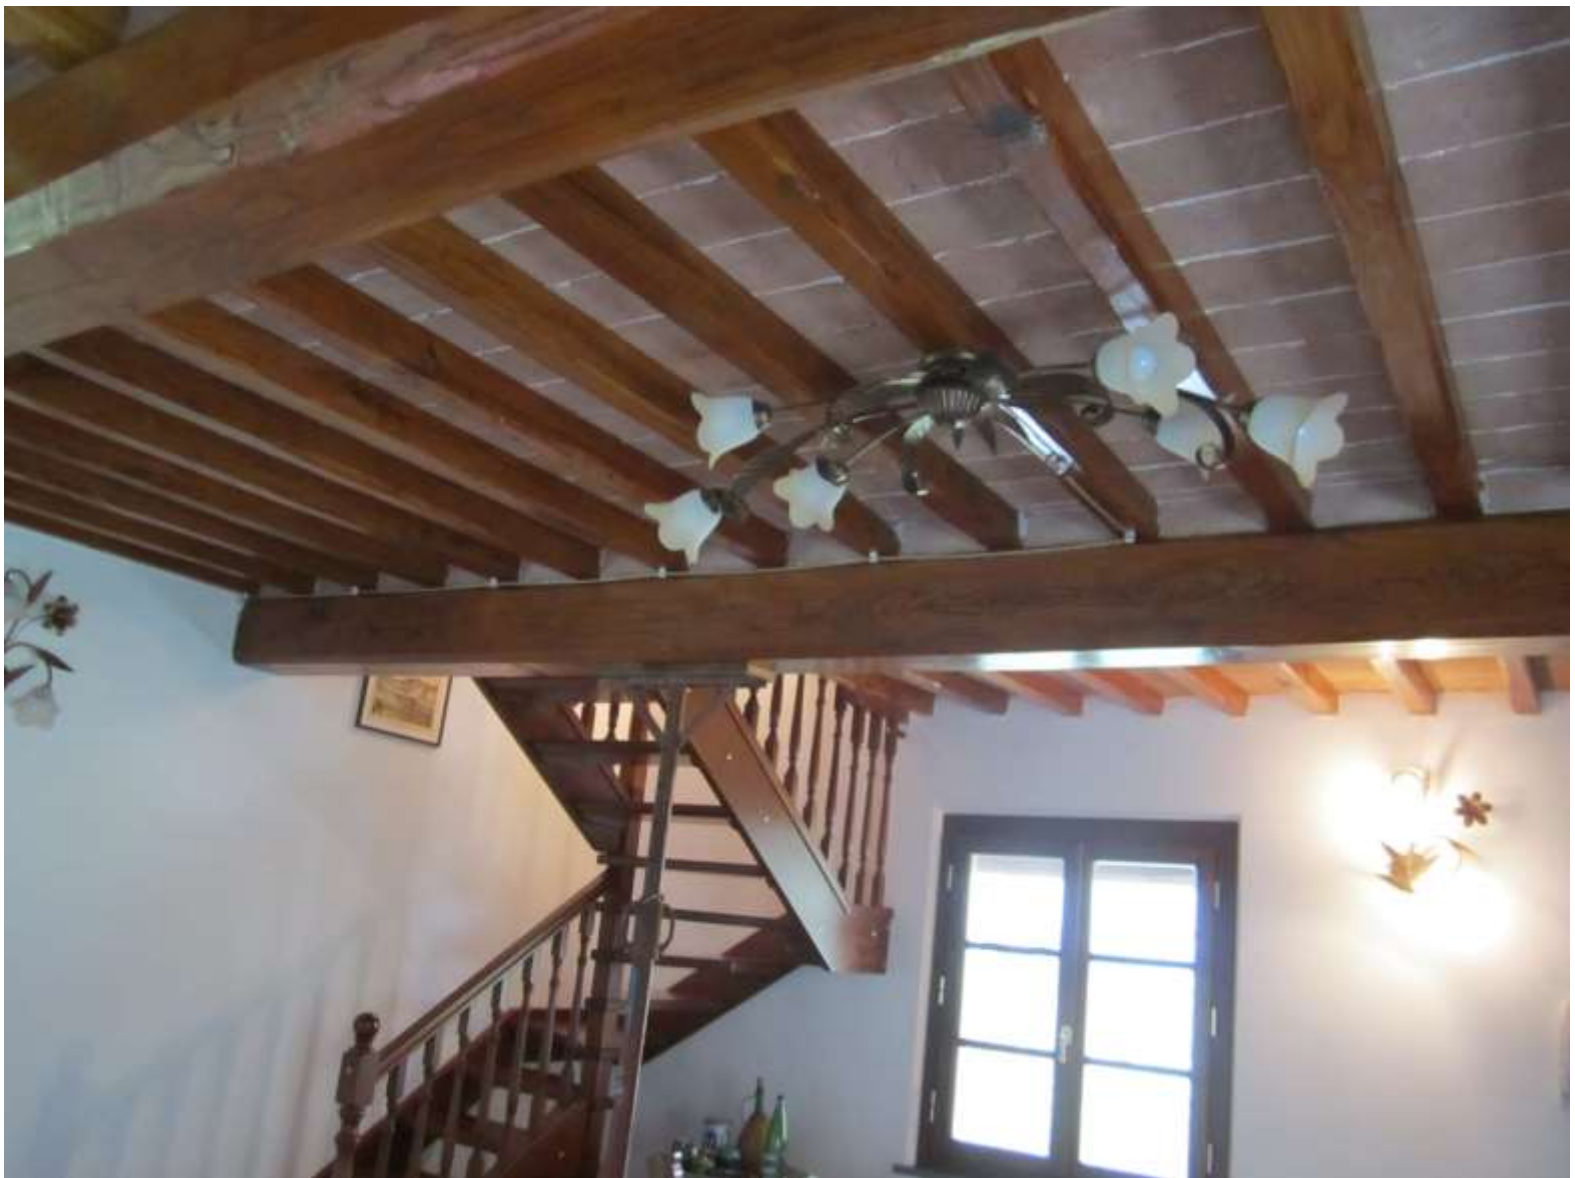
Beam supported with a pack prop

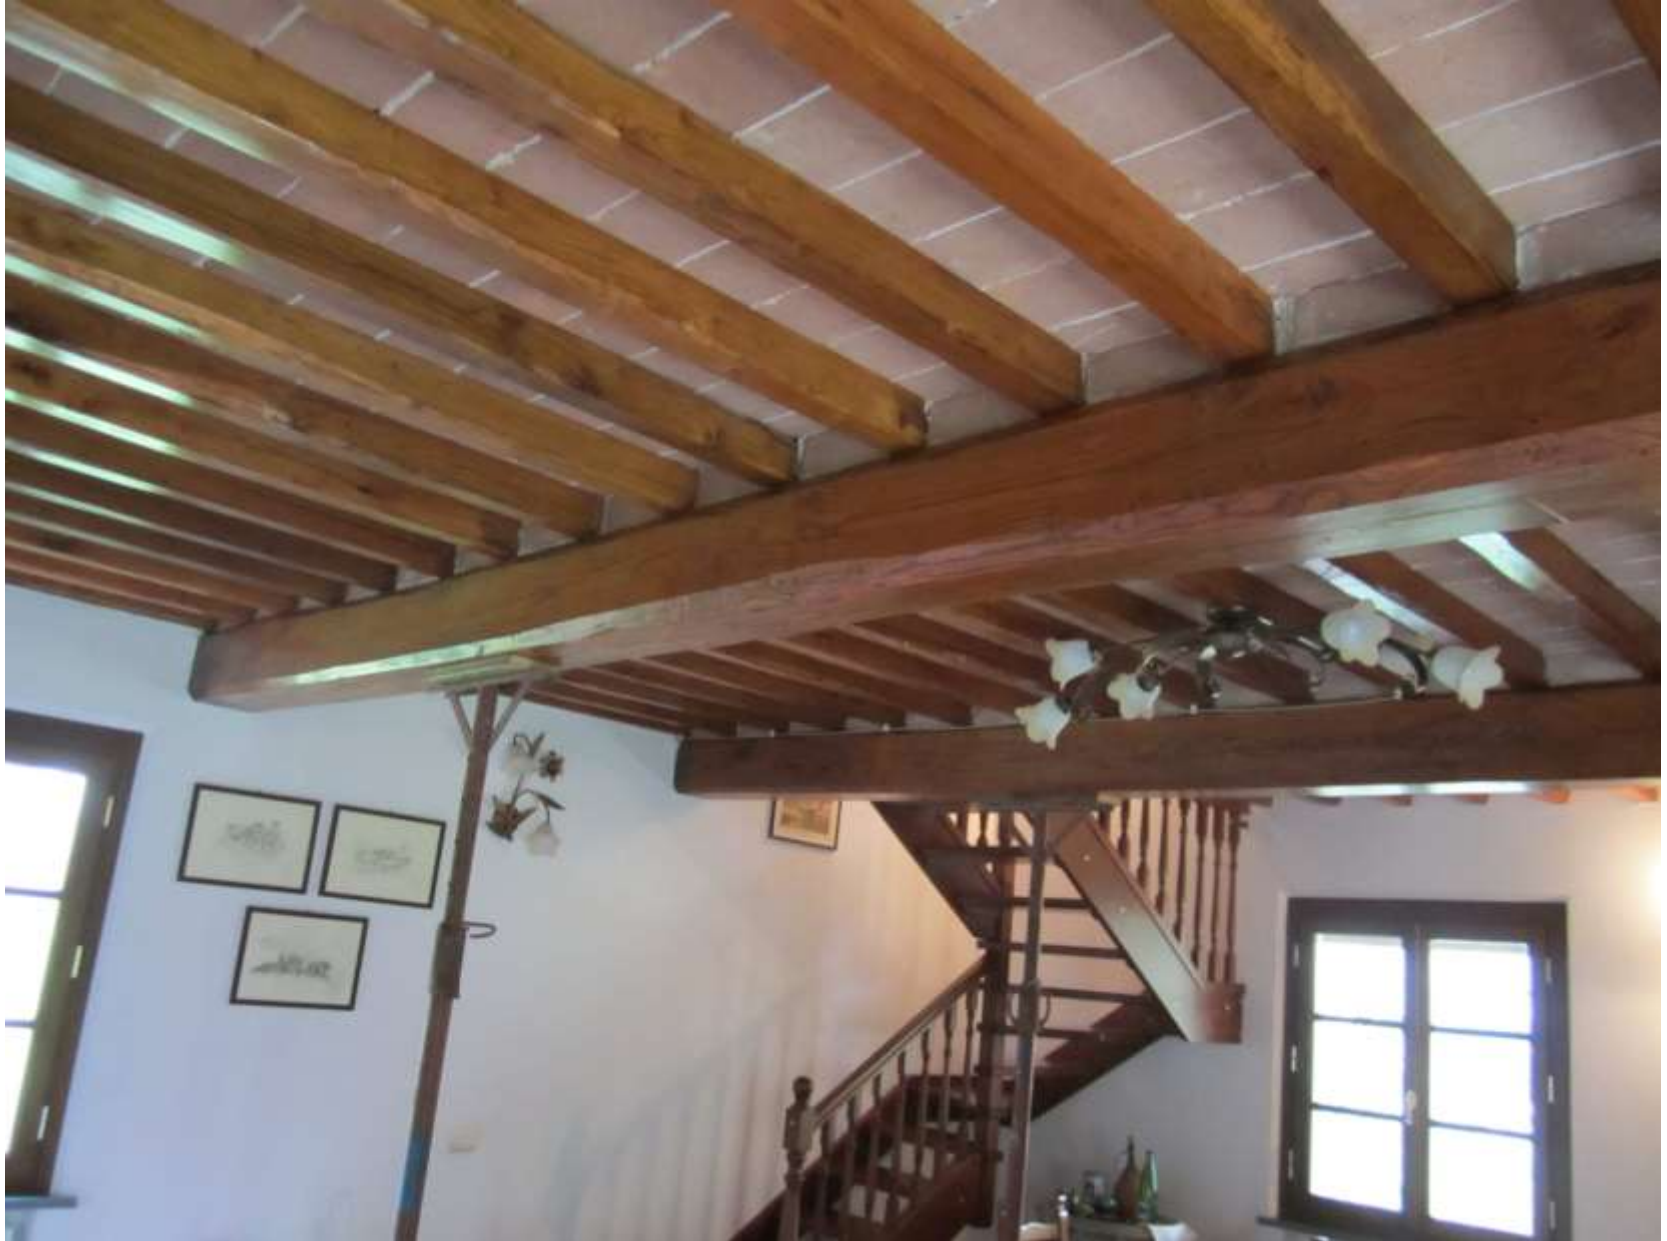
Beams supported with pack props

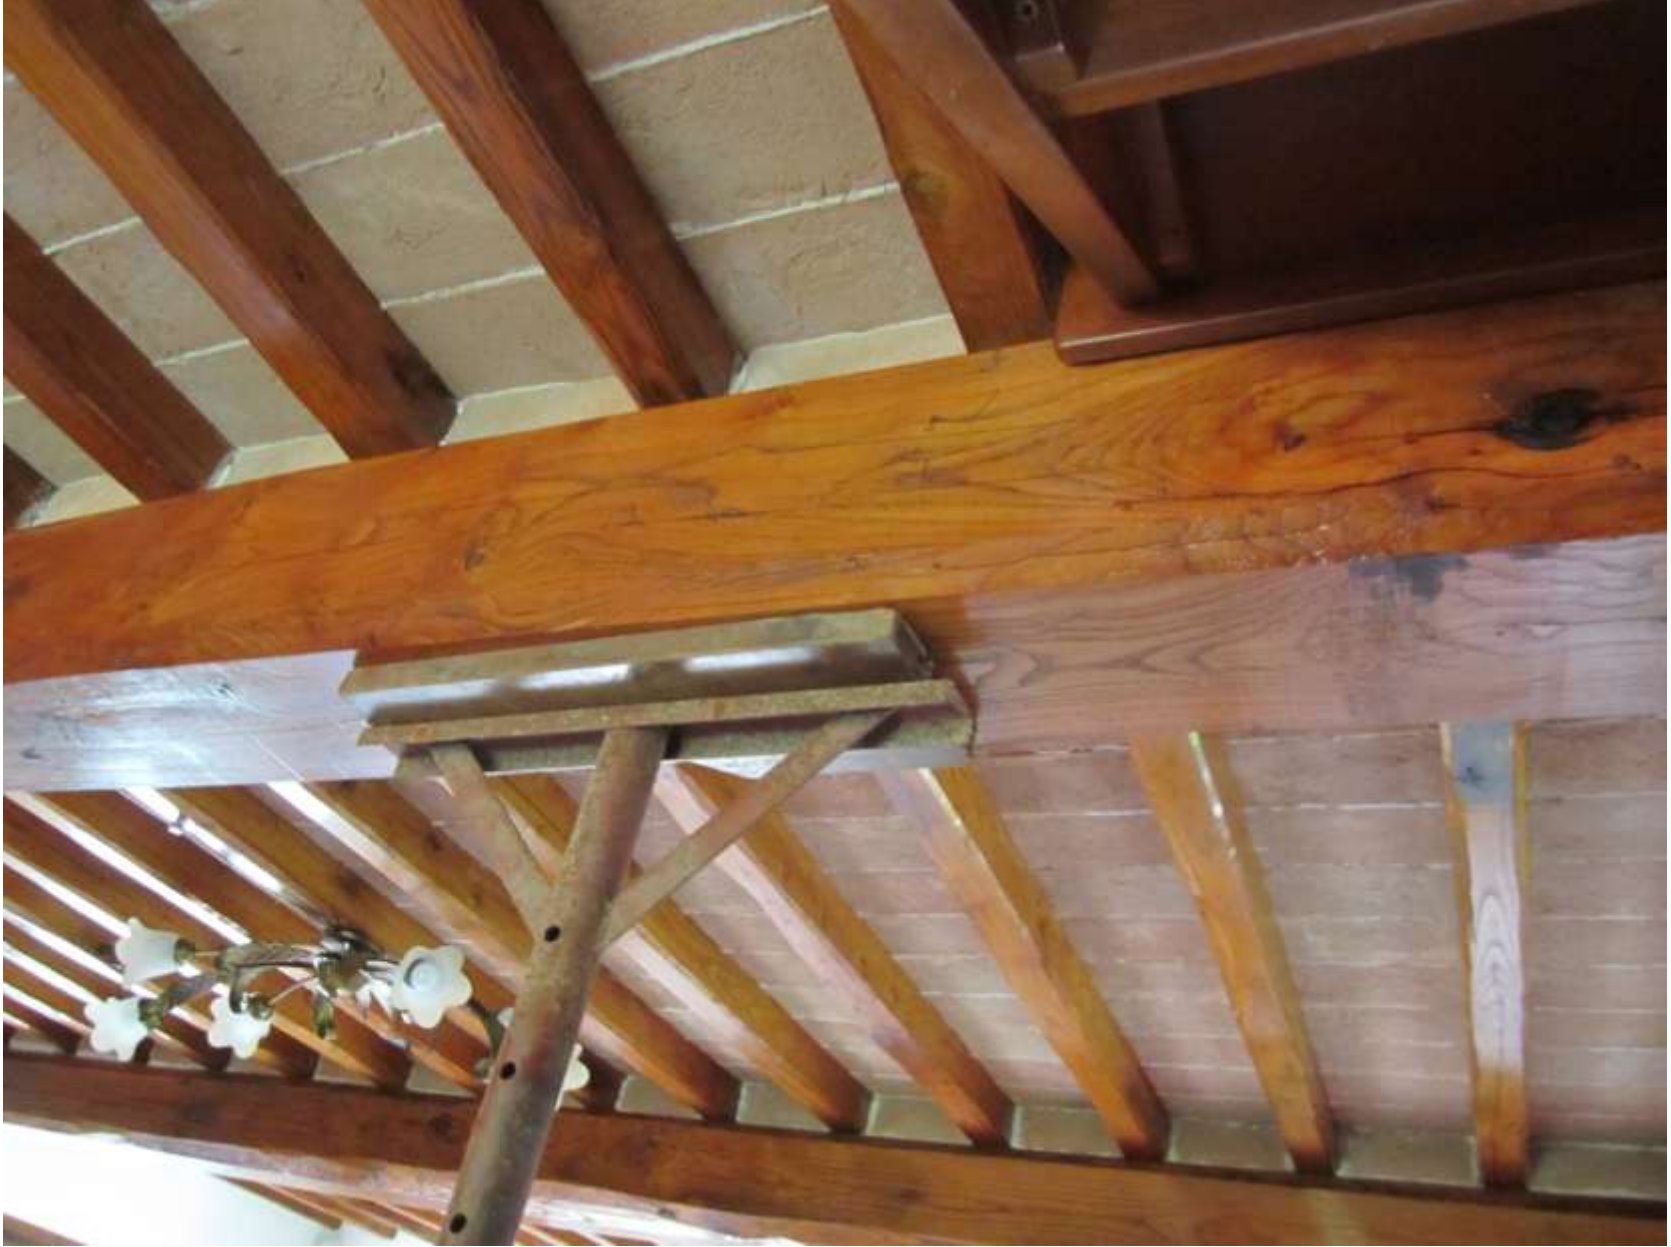
Support and crack

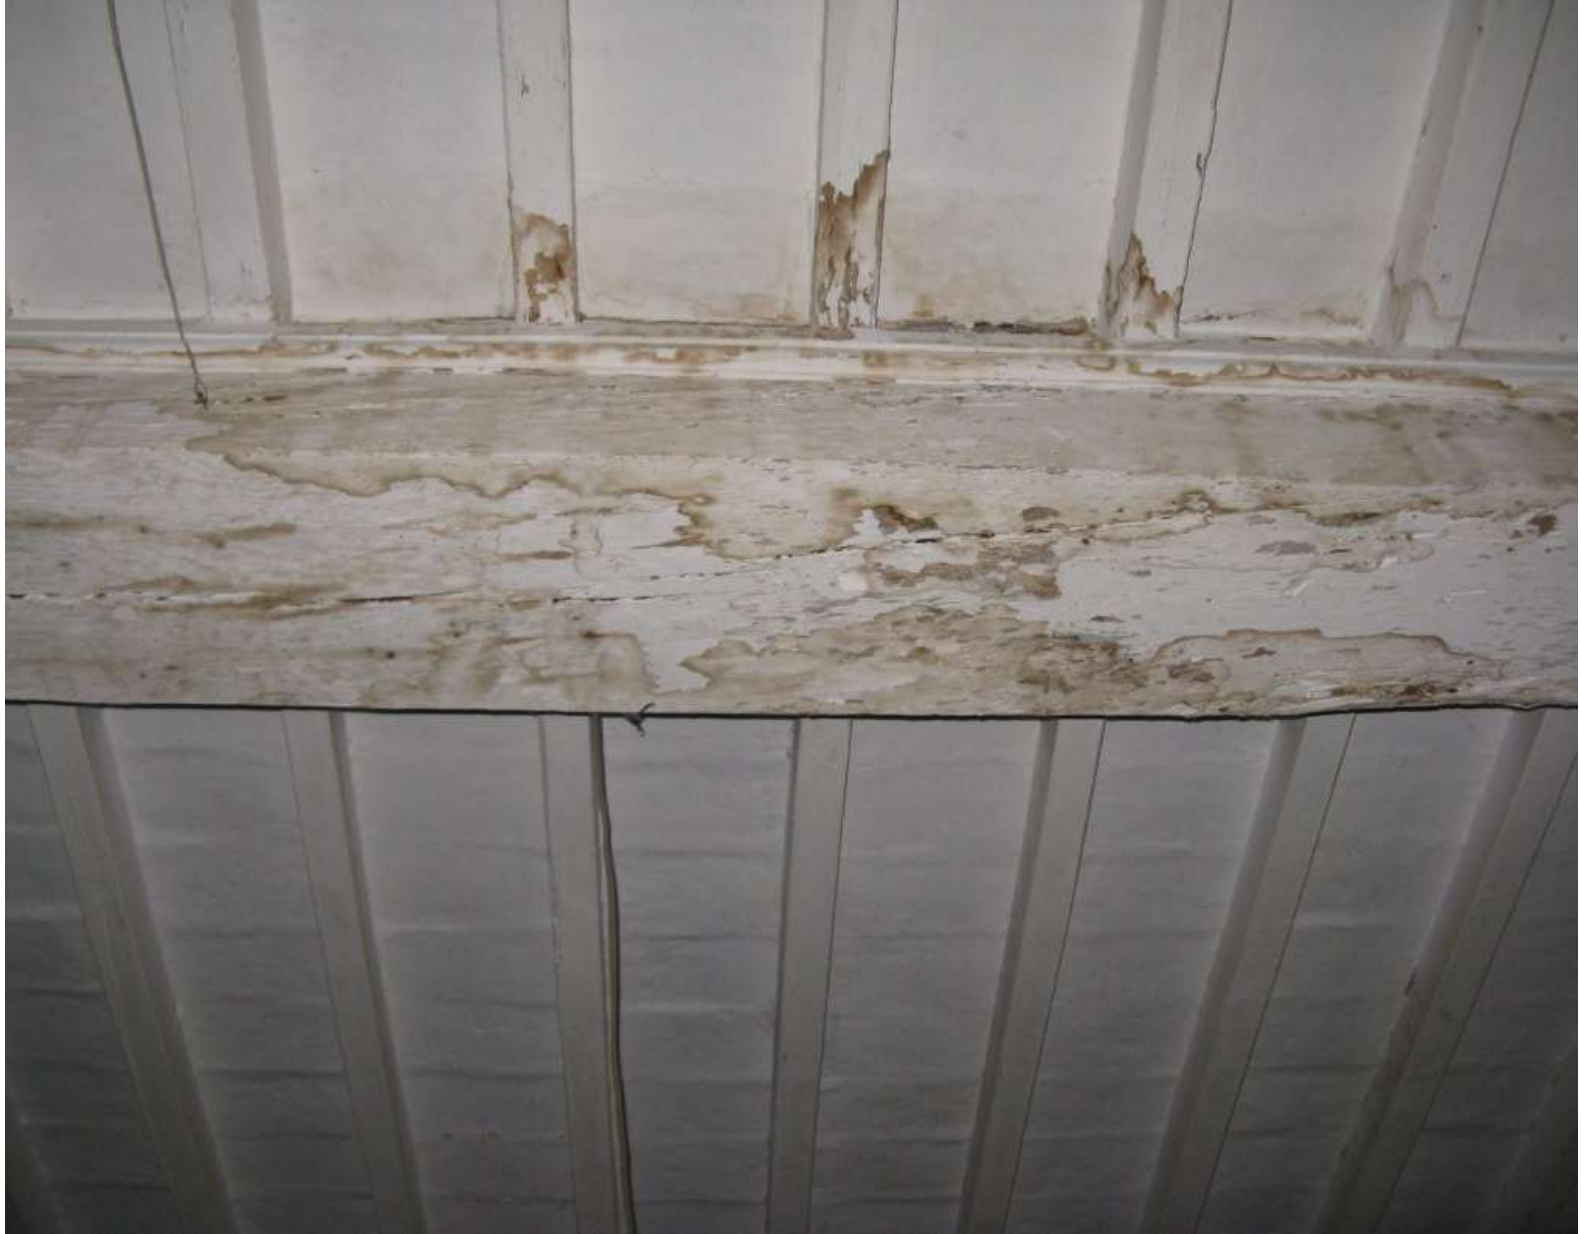
Crack pattern in a beam
