Timber structures

Case studies

PIETRO CROCE

Assessment of existing structures

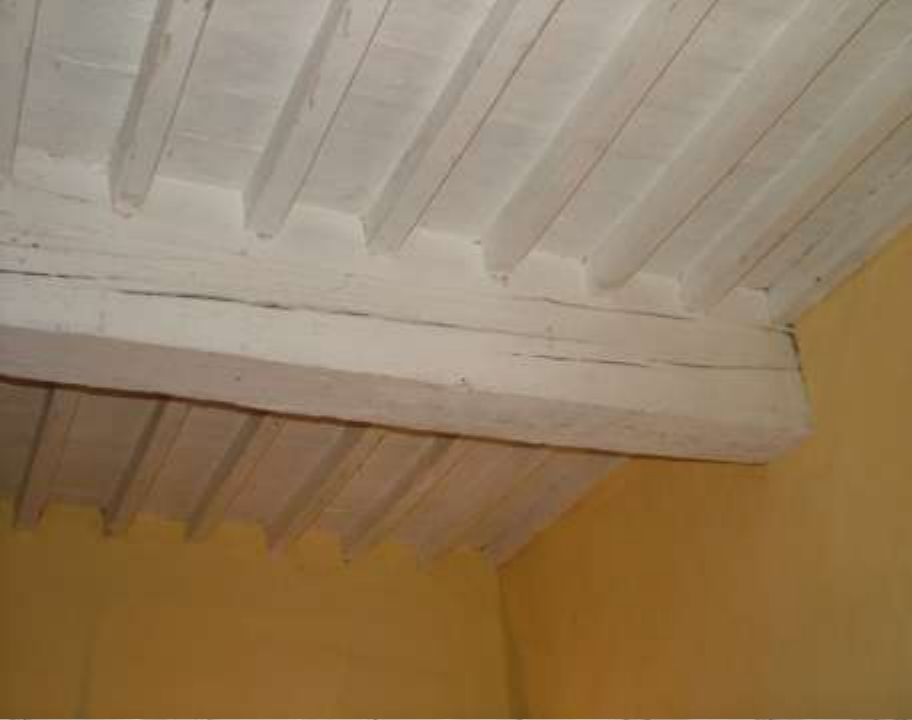
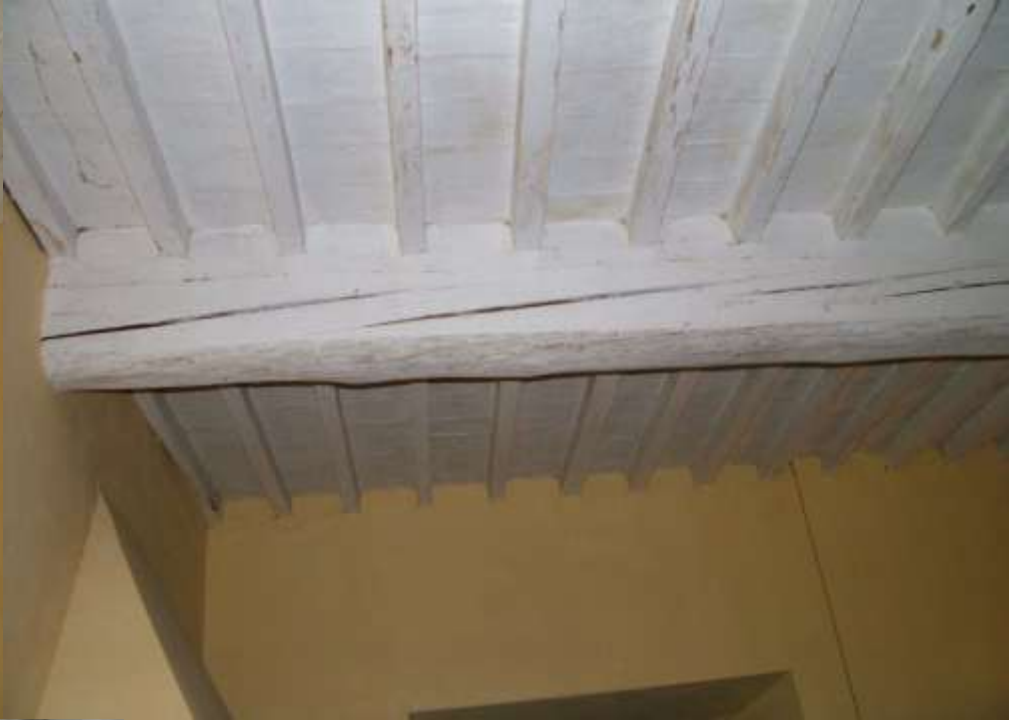
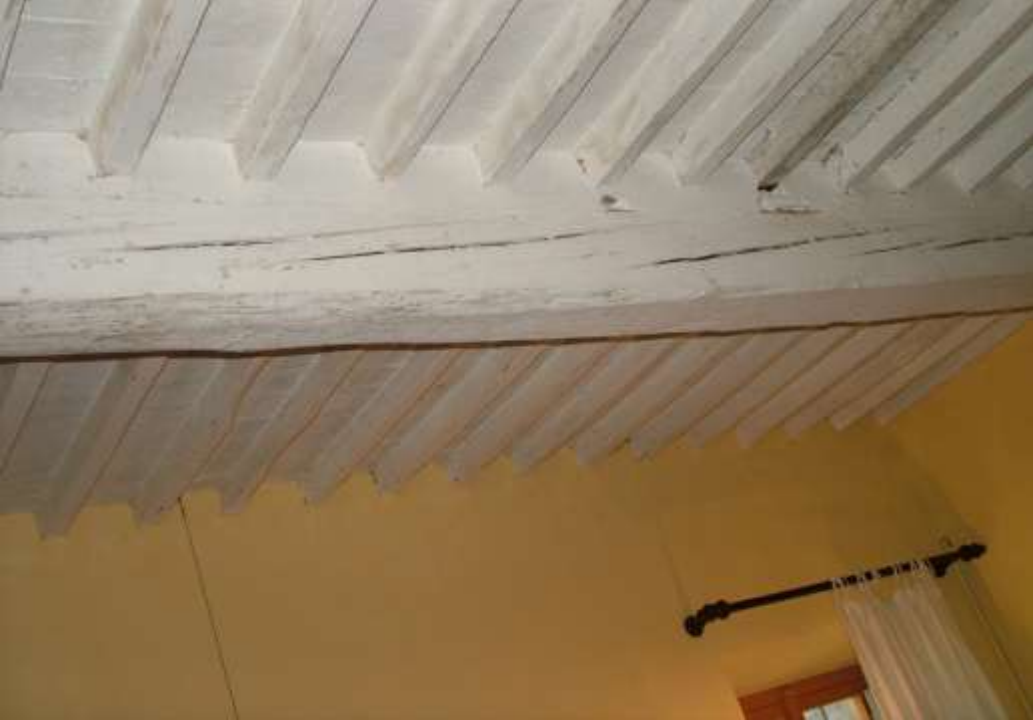
Typical crack pattern
