LEONARDO DA VINCI PROJECT CZ/11/LLP-LdV/TOI/134005 SEMINAR ON ASSESSMENT OF EXISTING STRUCTURES České Budějovice. 23-05-2013

ON THE ASSESSMENT OF SOUND, DETERIORATING AND COLLAPSED STRUCTURES

Peter Tanner. Carlos Lara. Ramon Hingorani. Miguel Prieto

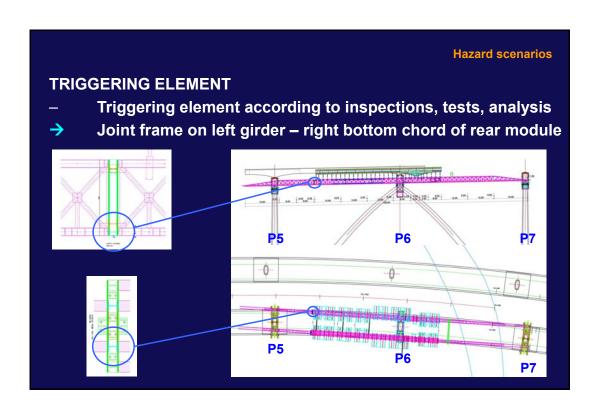
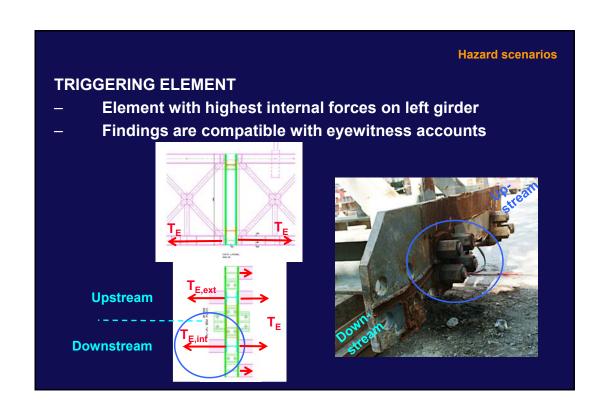
- Connection frames and adjacent modules connected by non-prestressed bolts
- Behaviour of bolts exposed to variable load cycles
 - Number of cycles to failure or bolt nuts loosening depends on ΔT_R
 - Mechanisms may be accelerated by sign-changing load cycles and dynamic effects

→ Loosening of bolt nuts may be relevant to the collapse
