### ON THE ASSESSMENT OF SOUND, DETERIORATING AND COLLAPSED STRUCTURES

- Introduction
- Updated models for the assessment of sound structures
- Corrosion-damaged reinforced concrete structures
- Analysis of the deteriorating main dome over La Laguna cathedral
- Collapse of the River Verde viaduct scaffolding system
- Final remarks

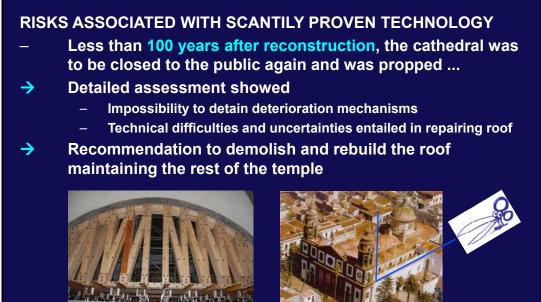
- Aggregates with inbuilt sulfates, chlorides, seashells, ...
- Concrete with high porosity and low resistivity
- High relative humidity and filtration of rainwater
- Ongoing deterioration mechanisms with severe damage to both, concrete and reinforcement
  - Corrosion
  - Spalling
  - · ...

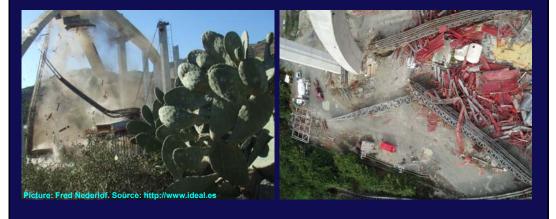
### CONSEQUENCES

- 6 persons killed and several injured
- Delay in construction and economic loss
- Loss of public confidence

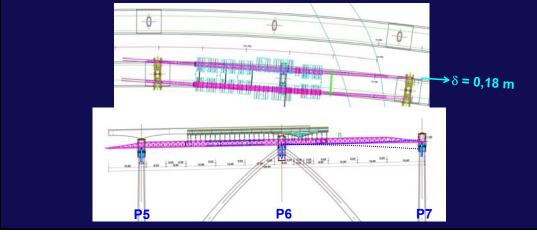
### **ACTION EFFECTS DUE TO IMPOSED DEFORMATIONS**

- Difference between left and right main girder travel: 0,18 m
- Deviations in MSS support elevations or main girder precamber

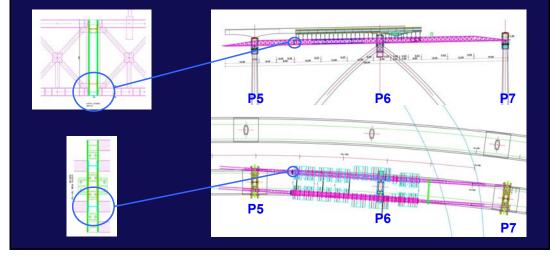
### **TRIGGERING ELEMENT**

- Triggering element according to inspections, tests, analysis
- Joint frame on left girder right bottom chord of rear module
