SEISMIC PERFORMANCE EVALUATION OF REINFORCED CONCRETE BUILDING IN TURKEY

Betonarme Binaların Sismik Performans Değerlendirmesi

Prof. Dr. Mehmet INEL
Pamukkale University, Denizli, TURKEY

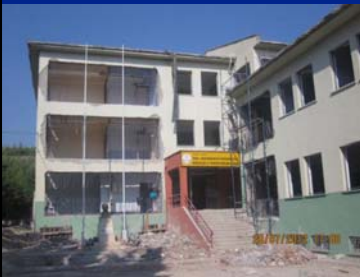
Adding / Strengthening Shear Walls

- Adding new R/C shear walls by replacing the partition walls

- To increase stiffness capacity
- To increase strength capacity
- To decrease displacement demand

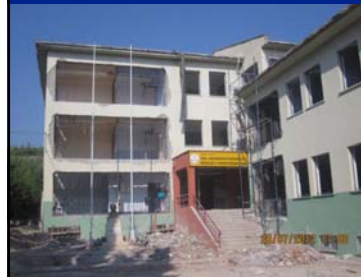
Perde Duvar Eklenmesi

- Mevcut dolgu duvarlar yerine perde duvar eklenmesi

- Rijitlik artışı
- Dayanım artışı
- Deplasman talebinde azalma

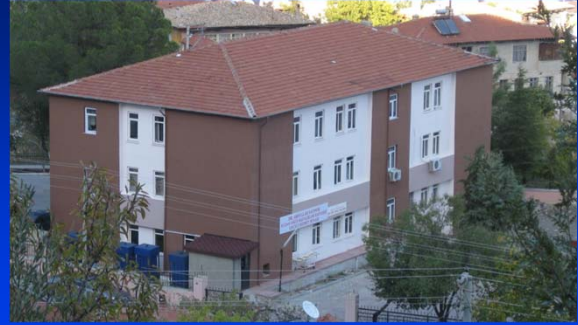
Strengthening by using external shear walls
Dış Perde Duvar

Same building after strengthening
