# Concrete structures

## Case studies

Assessment of existing structures

## STRENGTHENING OF R.C. COLUMNS

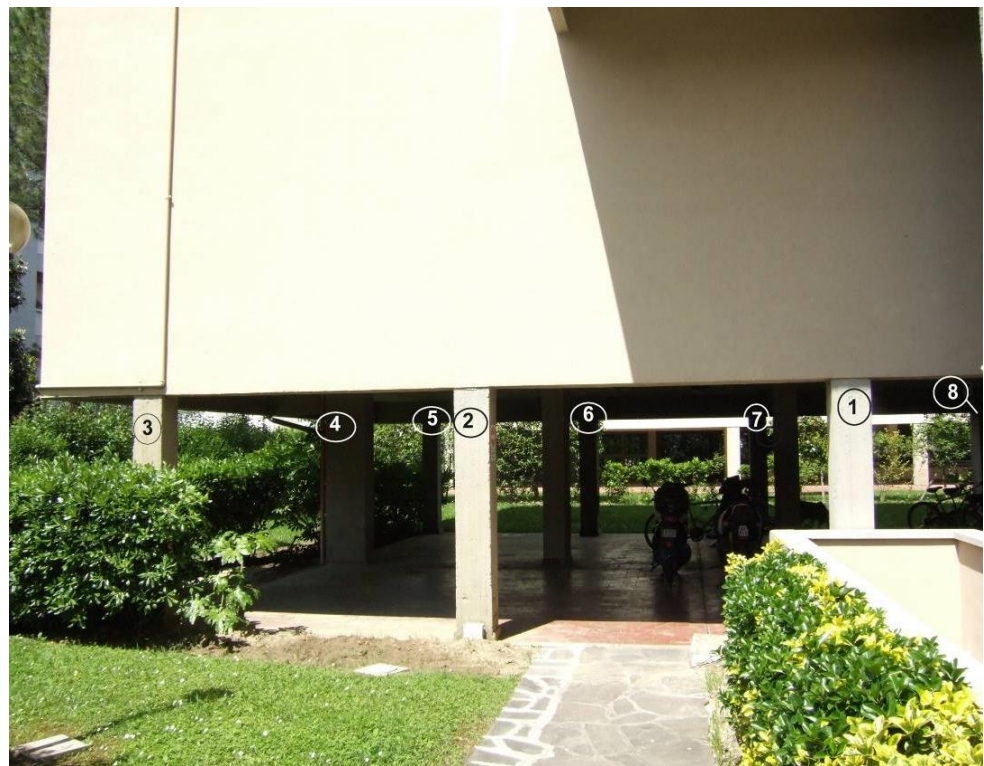
**Damaged columns**

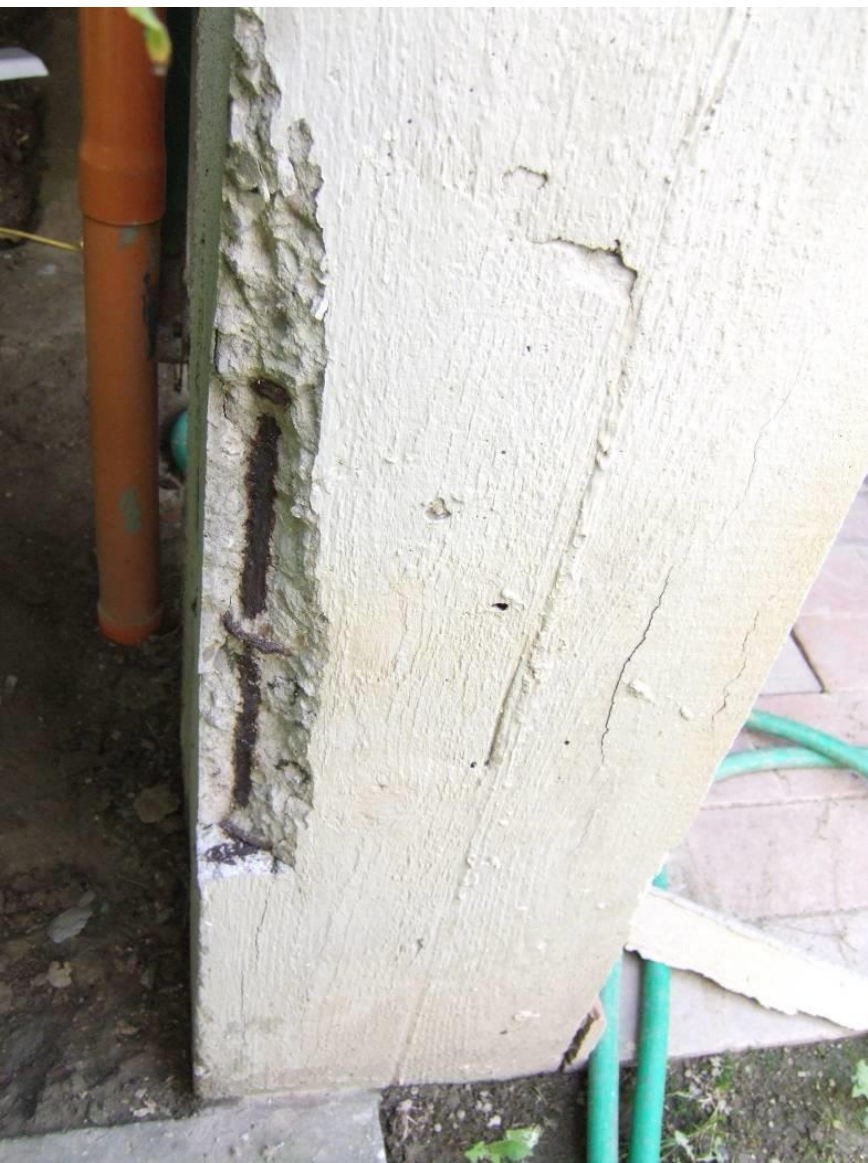
**Corroded rebars**

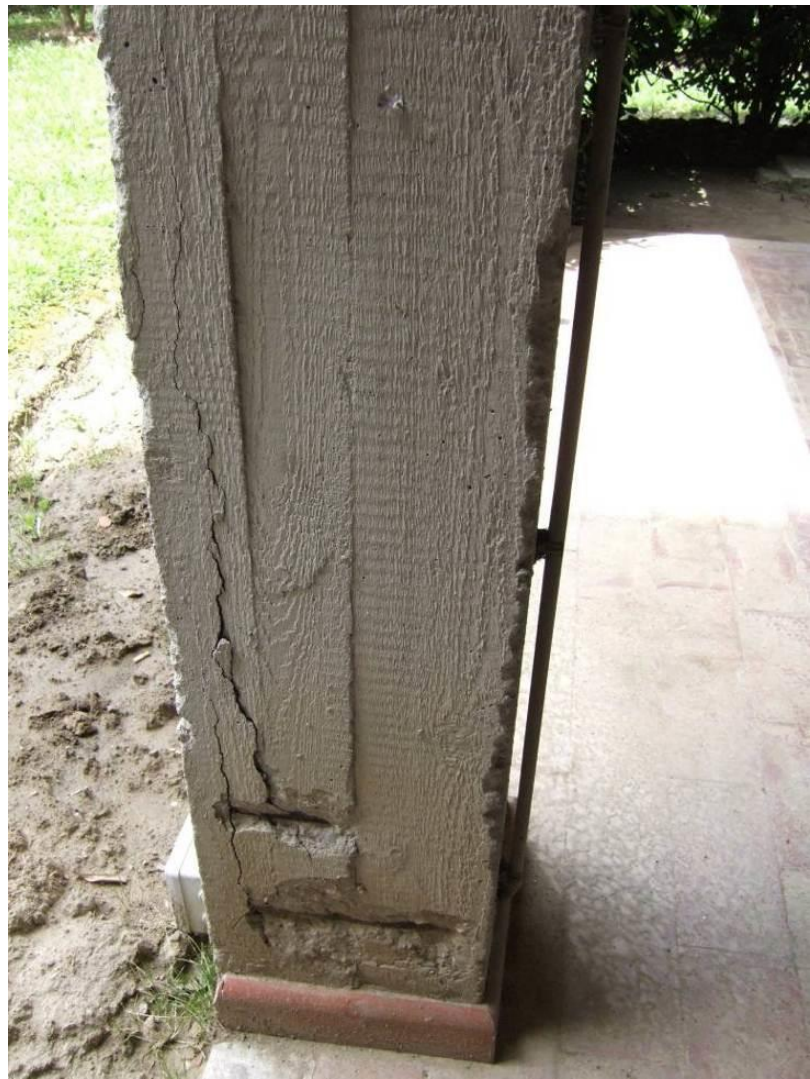
**Cracking of concrete  
cover**

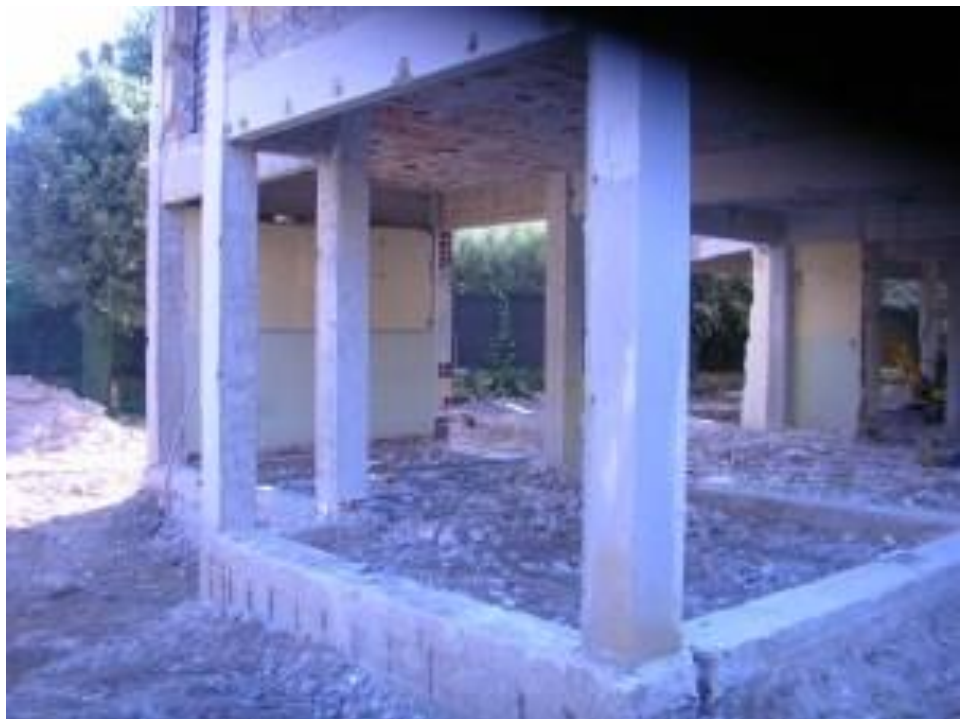
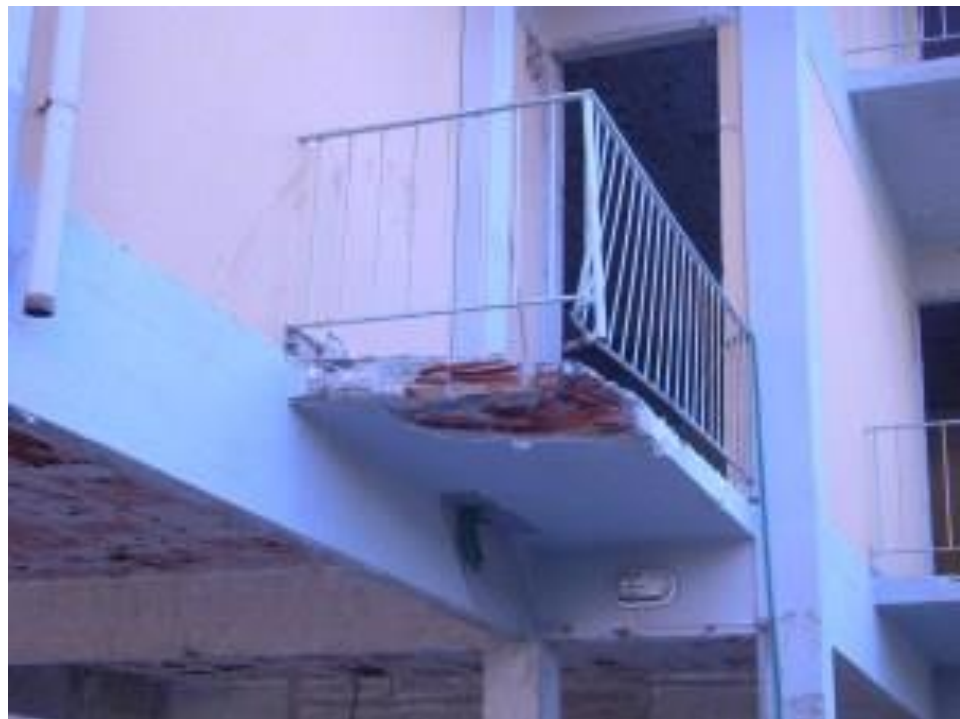
**Preliminary investigation phase**

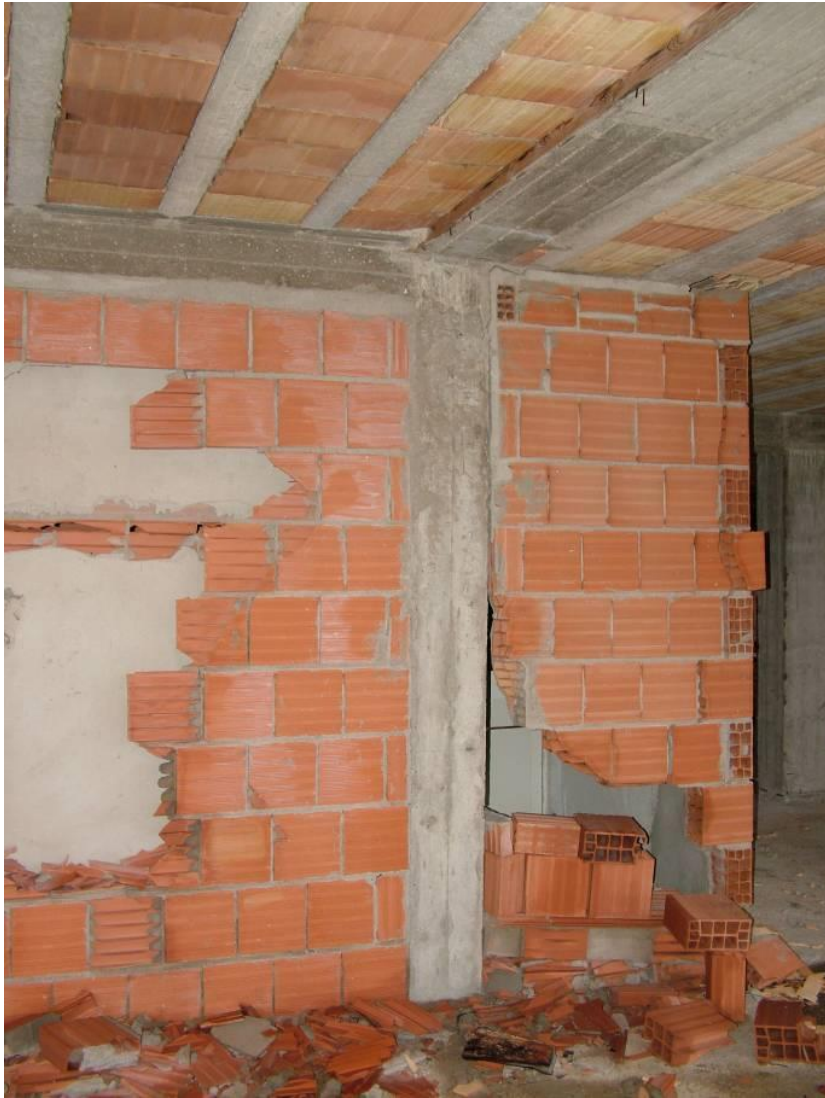
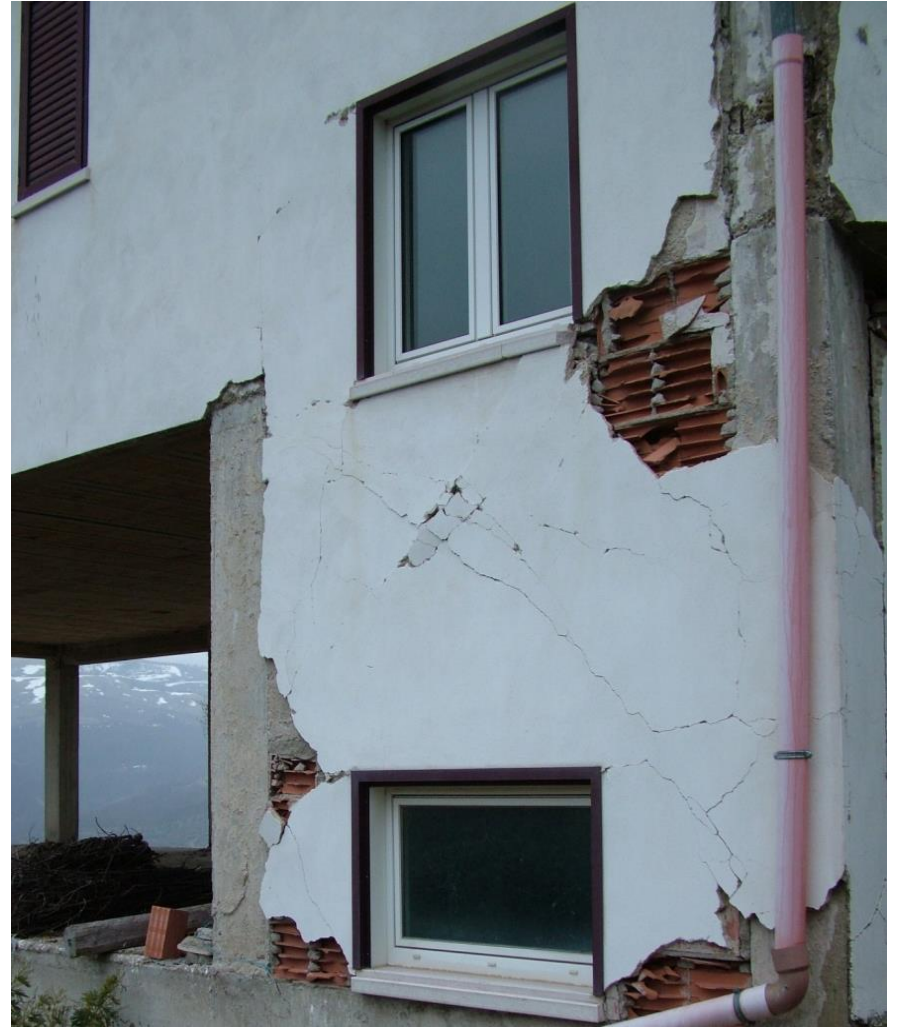
**Damages induced by the earthquake**

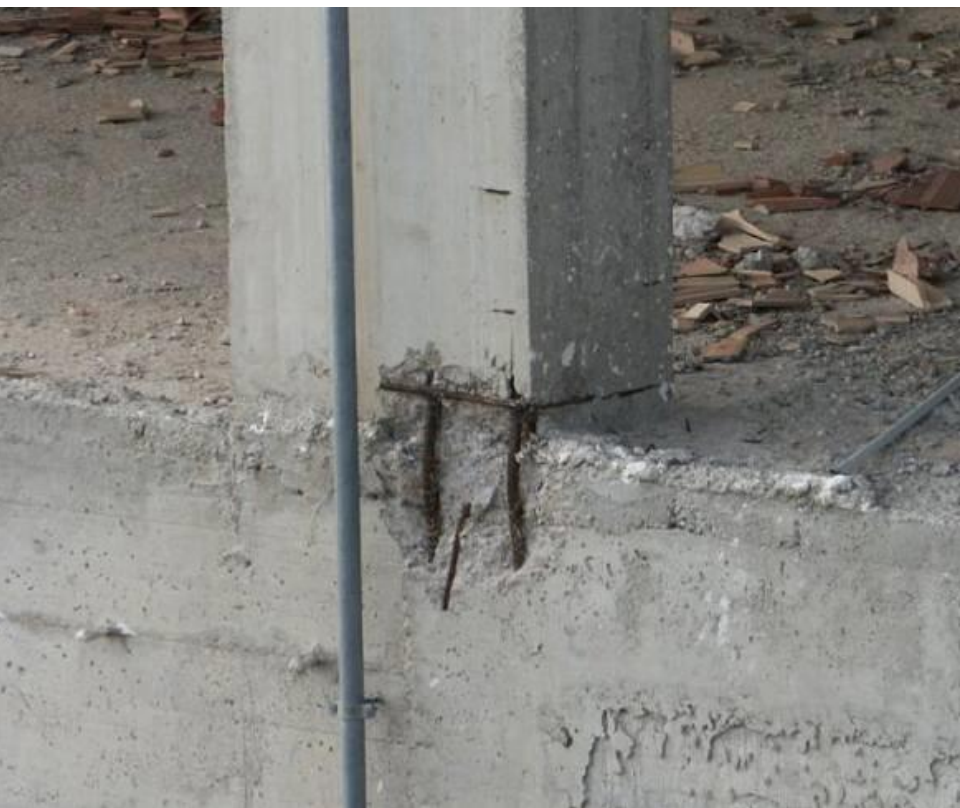
**Damages at the ends of the columns**
