LEONARDO DA VINCI PROJECT CZ/11/LLP-LdV/TOI/134005 SEMINAR ON ASSESSMENT OF EXISTING STRUCTURES České Budějovice. 23-05-2013

ON THE ASSESSMENT OF SOUND, DETERIORATING AND COLLAPSED STRUCTURES

Peter Tanner. Carlos Lara. Ramon Hingorani. Miguel Prieto

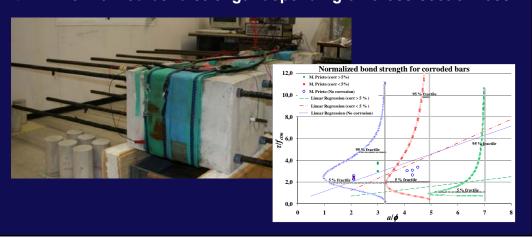
BOND STRENGTH

- Pull-out tests on specimens with accelerated and natural corrosion
- Normalized bond strength depending on cross-section loss

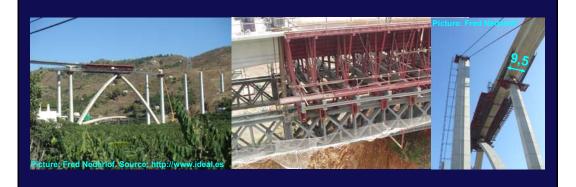
- MSS used to build the bridge superstructure
- Formwork supported by two main parallel truss girders, spaced at 9,5 m

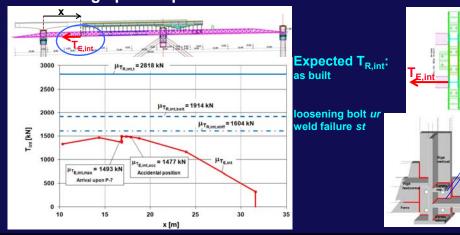
THE PROBLEM R - E

- Failure of critical joint induces system failure: series system
- → Assess P_{f,joint} associated with relevant hazard scenarios by using updated parameters for load and resistance variables
