### ON THE ASSESSMENT OF SOUND, DETERIORATING AND COLLAPSED STRUCTURES

- Introduction
- Updated models for the assessment of sound structures
- Corrosion-damaged reinforced concrete structures
- Analysis of the deteriorating main dome over La Laguna cathedral
- Collapse of the River Verde viaduct scaffolding system
- Final remarks

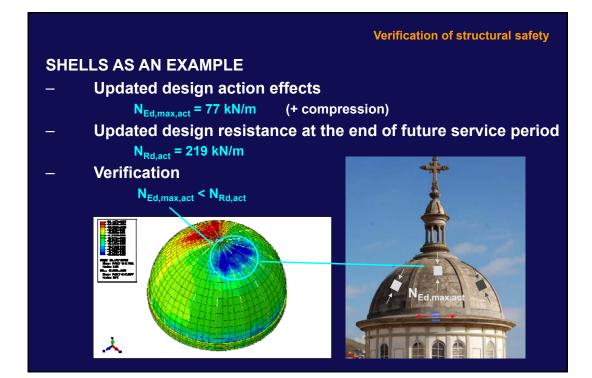
- Structural reliability can be verified, but
  - Severe damage to concrete and reinforcement
  - Impossibility to detain deterioration mechanisms
  - Technical difficulties and uncertainties entailed in repairing dome
- Demolition and reconstruction of the roof is advisable

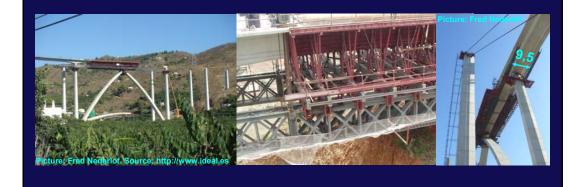
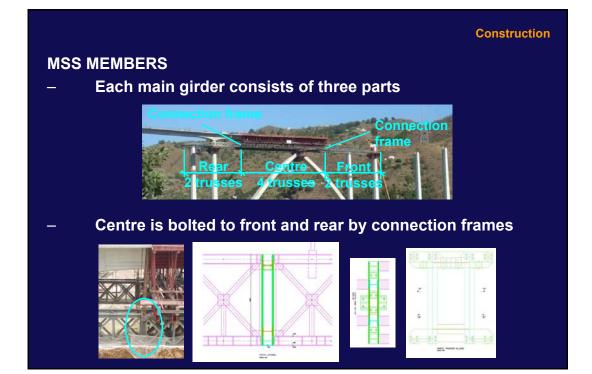
### **MOVABLE SCAFFOLDING SYSTEM**

- MSS used to build the bridge superstructure
- Formwork supported by two main parallel truss girders, spaced at 9,5 m

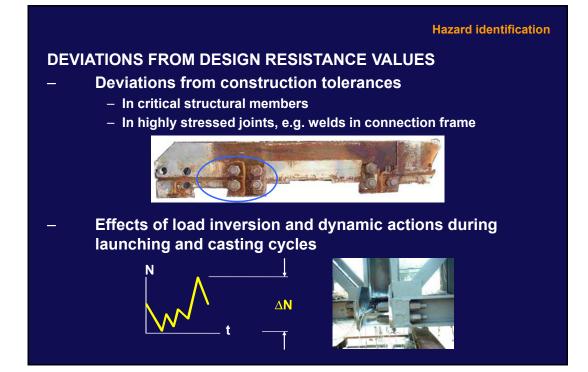
- Difference between left and right main girder travel: 0,18 m
- Deviations in MSS support elevations or main girder precamber

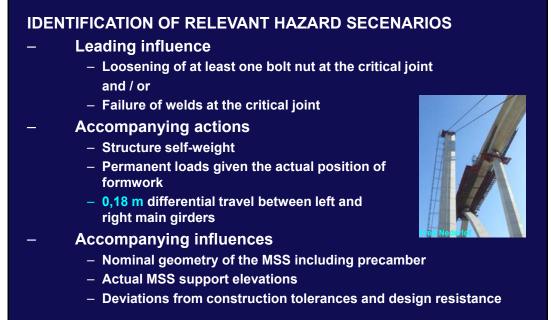
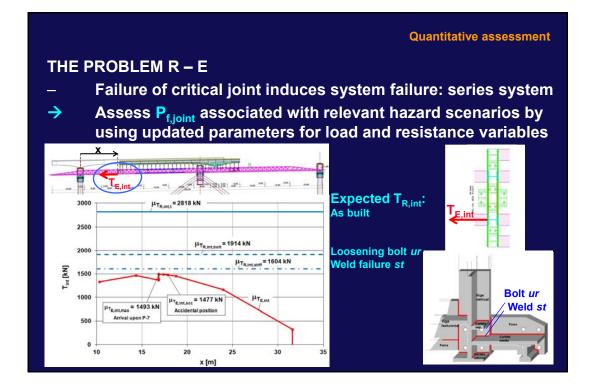
### Hazard scenarios

- Primary cause of joint failure could not be unequivocally established
  - More likely: loosening of one or several bolt nuts at the critical joint
  - Less likely: resistance loss in welds due to accumulation of plastic deformations
- → Hazard scenarios for quantitative analysis

- Assuming a loose upper right bolt at the critical joint
  - P<sub>f,int,bolt</sub> = 0,06 >> P<sub>f,adm</sub>
- After weld failure at intermediate stiffener
  - P<sub>f,int,stiff</sub> = 0,30 >> P<sub>f,adm</sub>
- → Unstable equilibrium at the critical joint

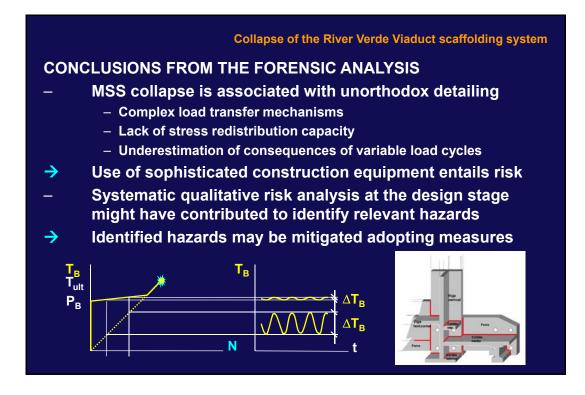
### FAILURE MECHANISM

- Results from analysis are compatible with inspections, tests and eyewitness accounts
- Most likely failure mechanism
  - Load inversion and dynamic effects during previous construction
  - Loosening of one or several bolt nuts at critical joint
  - Intra-joint stress redistribution
  - Stress concentration in certain welds
  - Failure of highly stressed welds
  - Stress redistribution and failure of other components
  - Joint failure
  - Collapse
