Timber structures

Case studies

PIETRO CROCE

Assessment of existing structures

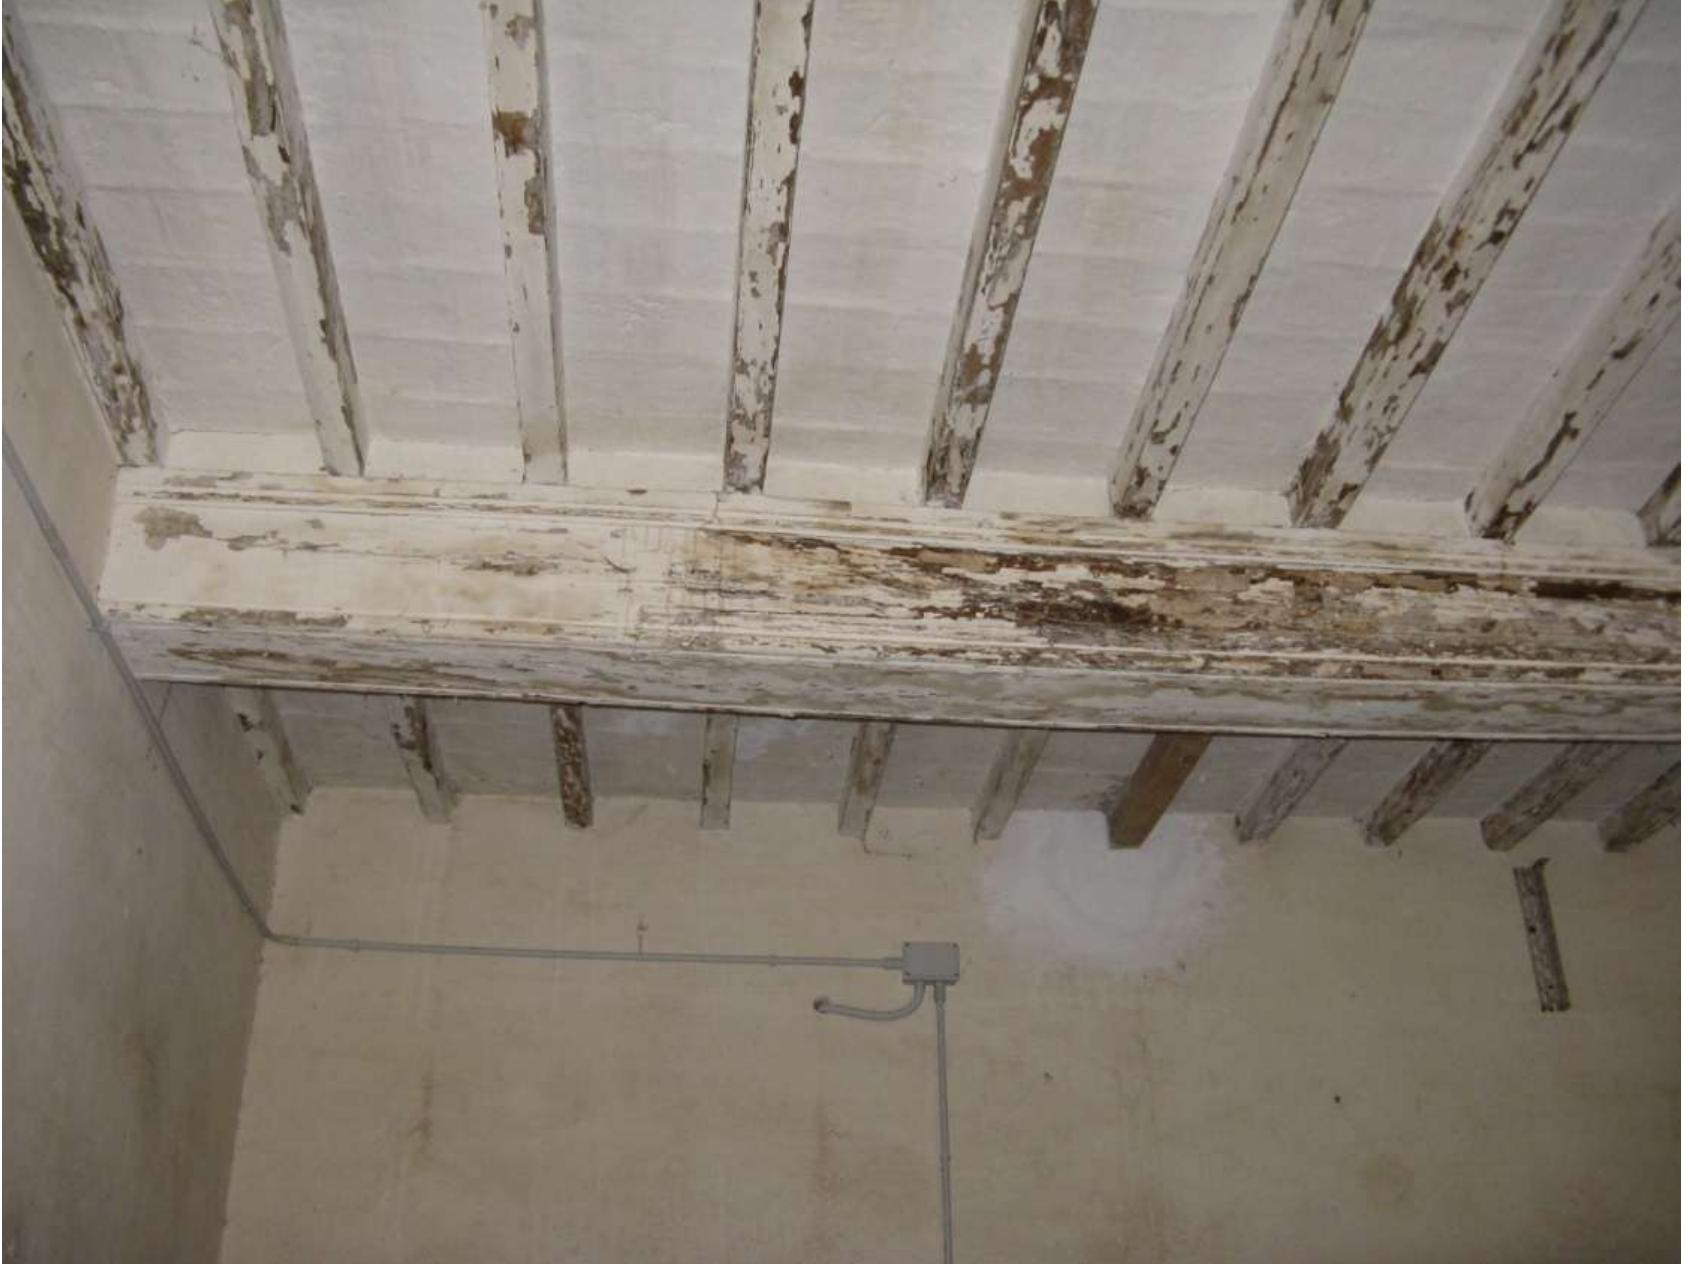
Beam covered with wood plates

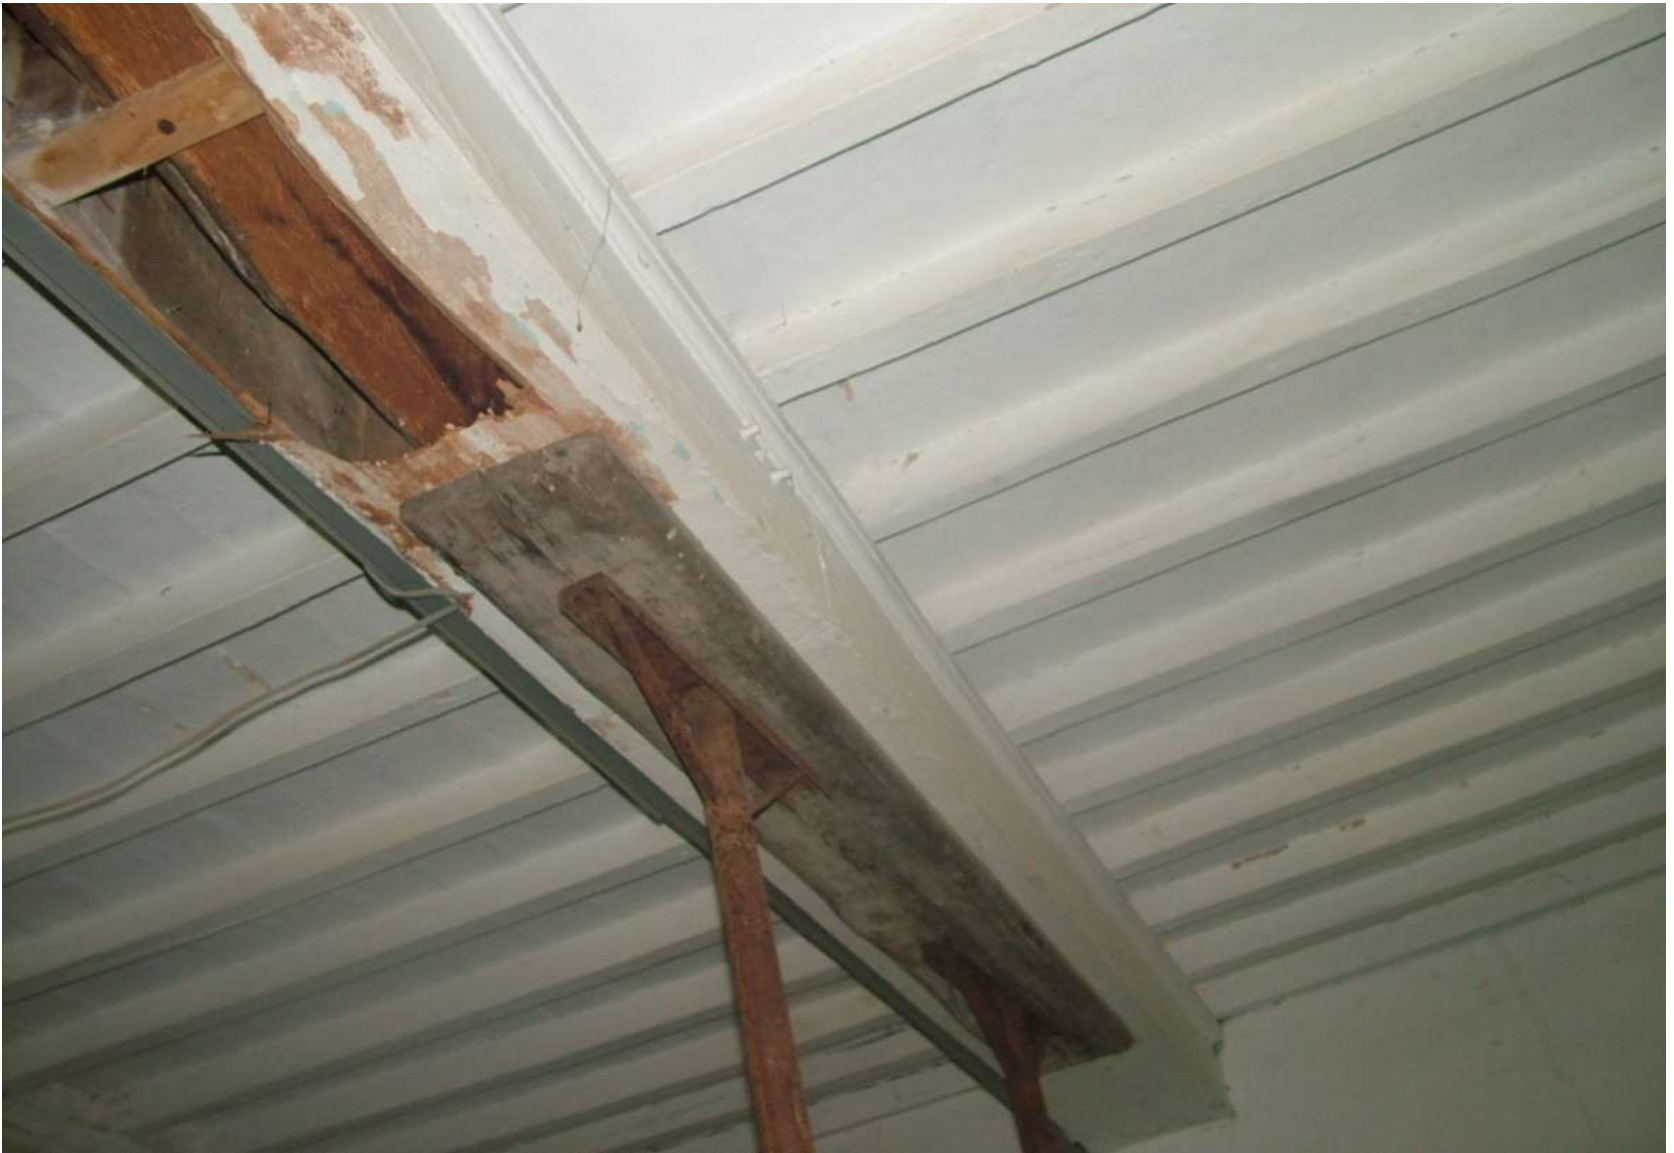
A surprising arrangement of the cover

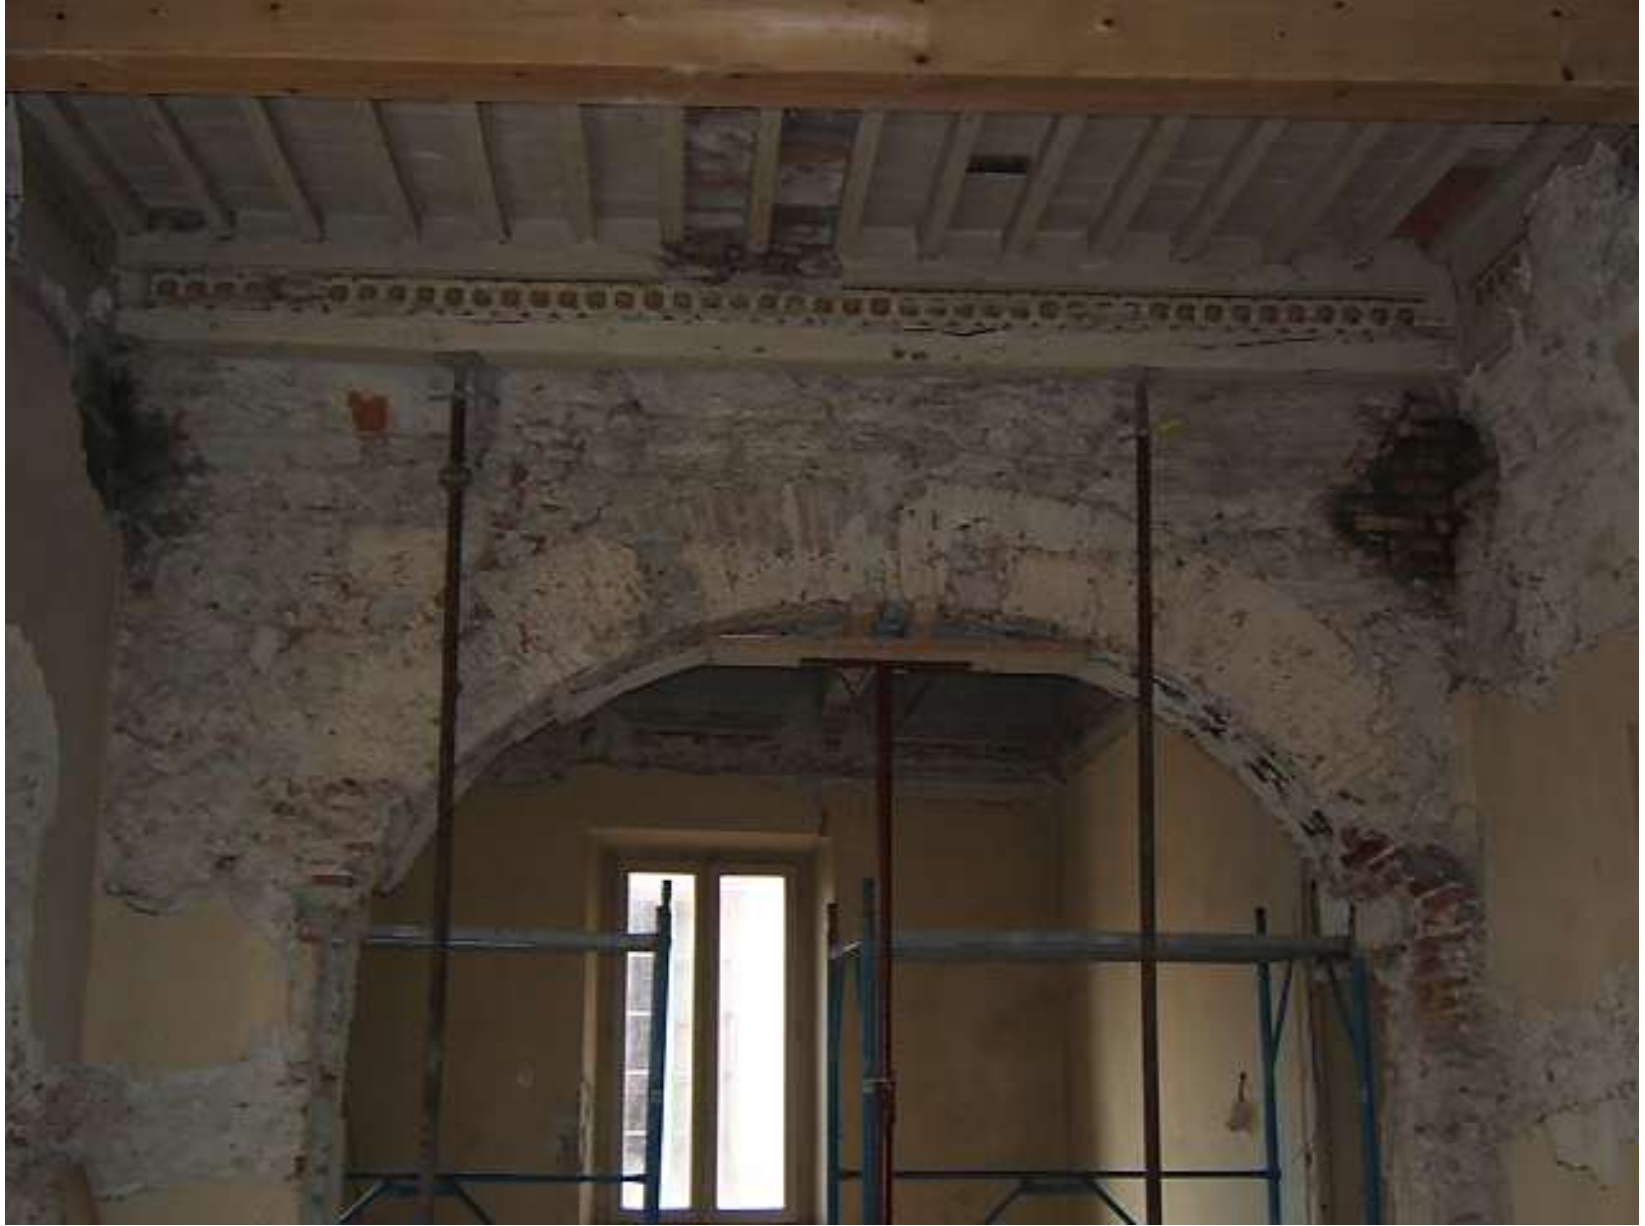
Arch to be strengthened
